FIELD REPORT

Field Report No. 2

Date: May 6, 2016
Project: Madison County Courthouse
Preliminary Leak Investigation at Cupola
Canton, Mississippi
BSA No. 1208.2

Purpose of Site Visit: Further Investigation of Cupola to identify locations of water intrusion.

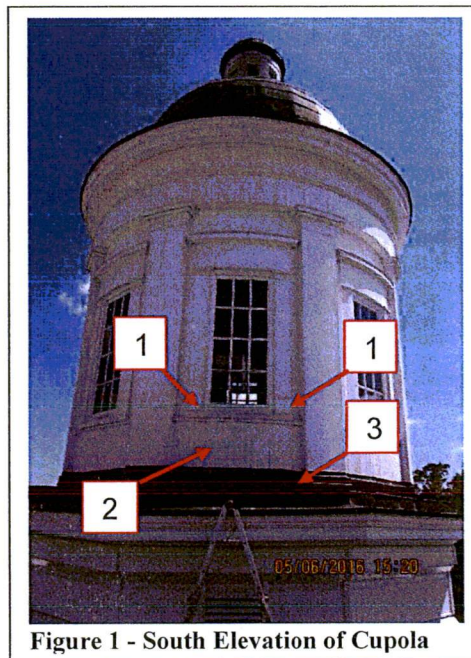
Figure 1 - South Elevation of Cupola

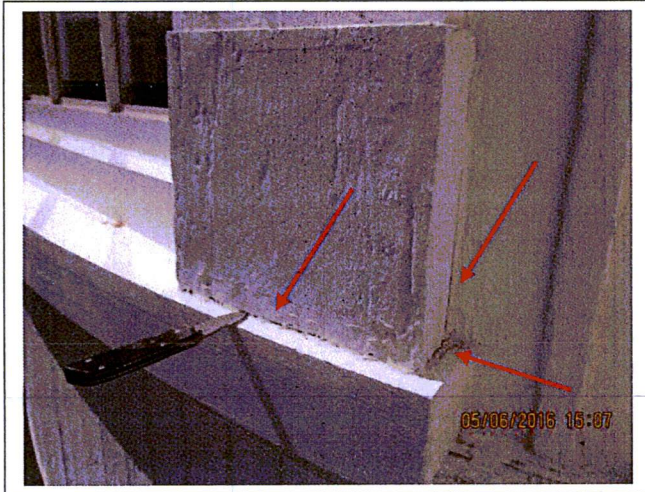
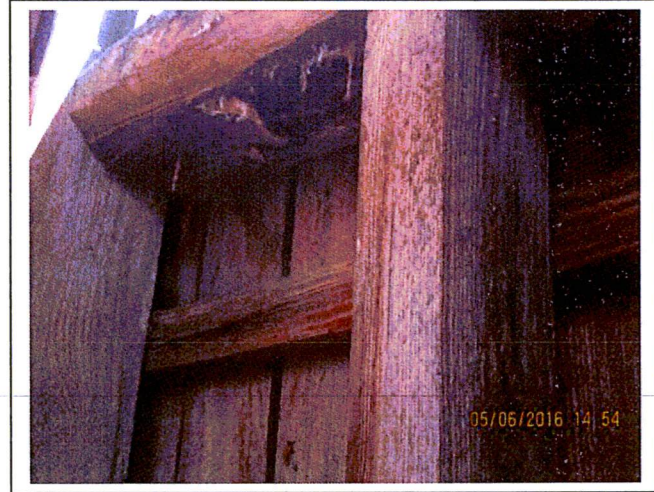
1 - WINDOW SILLS

1. Sealant: The sealant at the base of the vertical wood trim at the both sides of the South Facing Window has failed and separated, leaving open paths for water to the interior especially during significant heavy and blowing rain conditions.
2. Due to water leaking at the sill for an extended period of time, the interior wood sill at the South Window has severely rotted (completely through) and has become loose from other wood supporting vertical members.
3. The South Window Sill also has a slight "crown" at the center diverting water to the base of the trim at either side.

Recommendations: In the short term, all sealant at base of the vertical wood trim (Both sides of Sill) at the South Window should be removed, joints cleaned out and new sealant installed to minimize water intrusion into the Courtroom space. Due to limited lifespan/effectiveness of sealants, the removal and replacement of all existing exterior sealant at windows around the Cupola and replacement/repair of damaged/rotted wood window support sills and surrounding wood members should be included in the work scope of a Cupola Restoration/Repair Project.

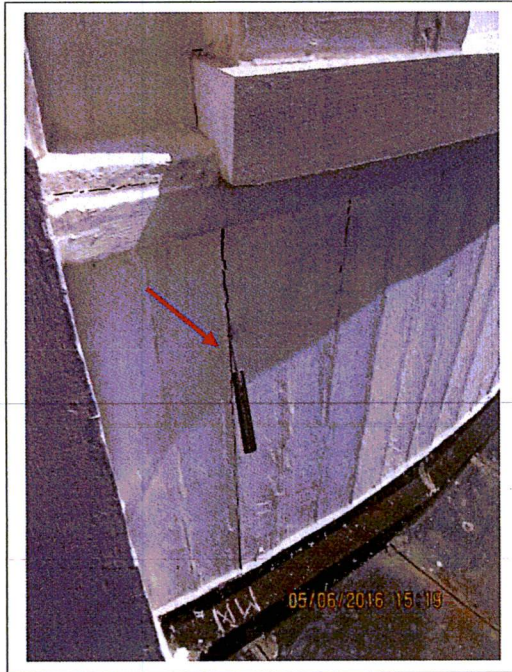
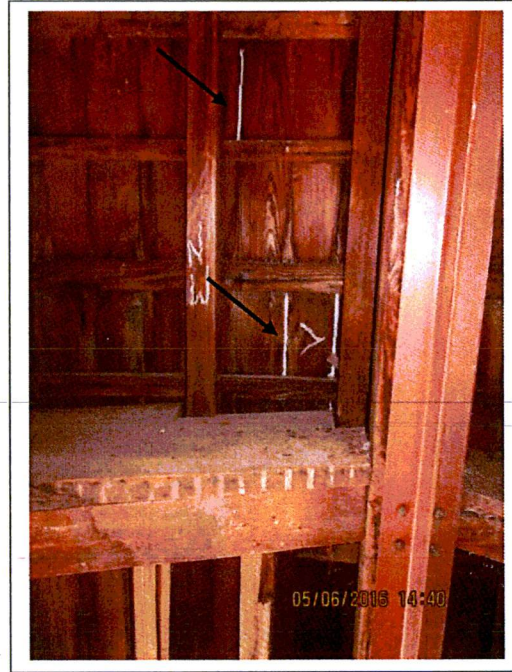
2 - VERTICAL WOOD SIDING JOINTS

1. Several of the vertical tongue and groove siding boards have separated, leaving open joints. Daylight could be seen from the interior of the cupola in some locations and there are water stains on the backsides of most boards. Some attempts in the past to fill the joints with sealant was observed.

Recommendations: In the short term, all vertical siding should be examined, open joints identified and sealed at the exterior face. As part of a Restoration/Repair Project, all vertical tongue and groove siding should be removed and deteriorated boards discarded. Any existing boards in good condition should be salvaged, restored to a well-maintained condition and reinstalled. New exterior grade tongue and groove wood siding boards, matching the existing exactly, should be used for replacement where required. A continuous sealant bead of sealant should be installed in the groove of each board. Damaged/deteriorated interior support framing boards should also be carefully examined, identified and replaced as required. All perimeter joints should then be appropriately sealed. The application of primer and exterior grade elastomeric paint/coating will protect the wood and allow for some movement capabilities. Options for the replacement of the wood siding may also be considered to either limit or eliminate the joints all together. Any alternative material considered will require careful attention to detail in order to retain the look and character of the cupola as well as the approval by MDAH.

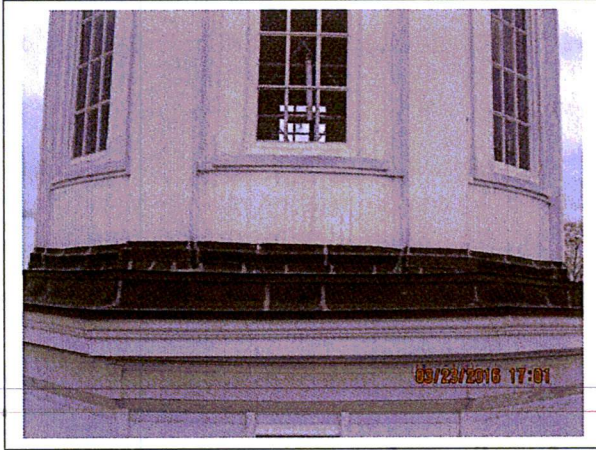
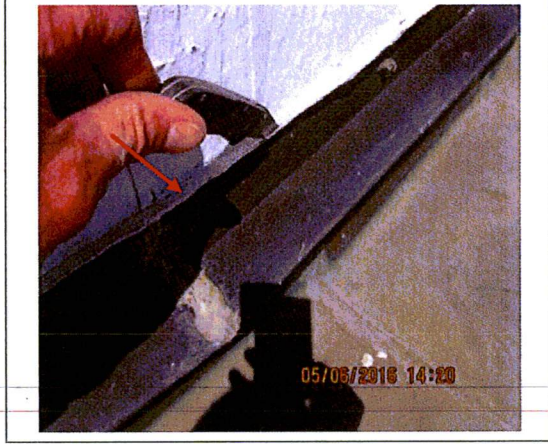
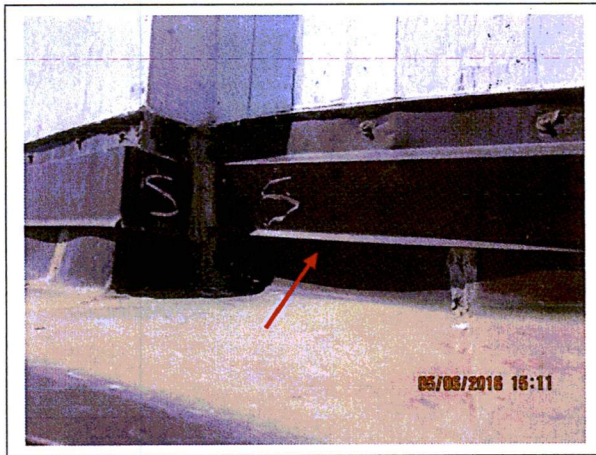
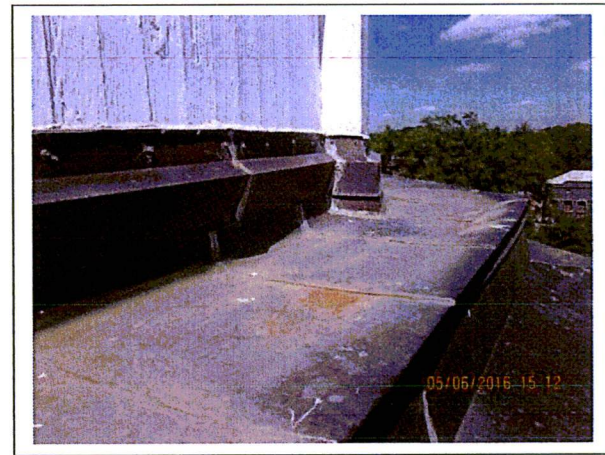
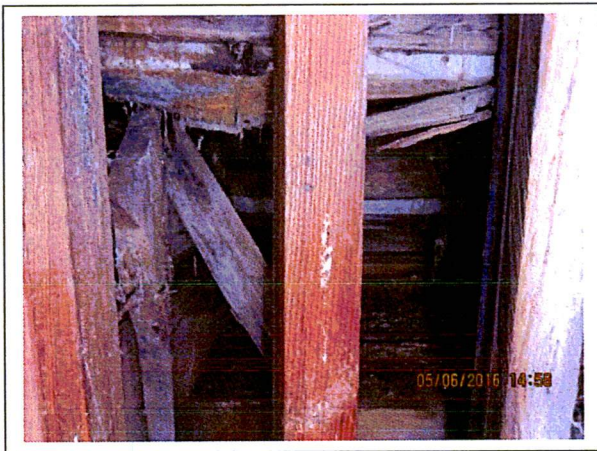
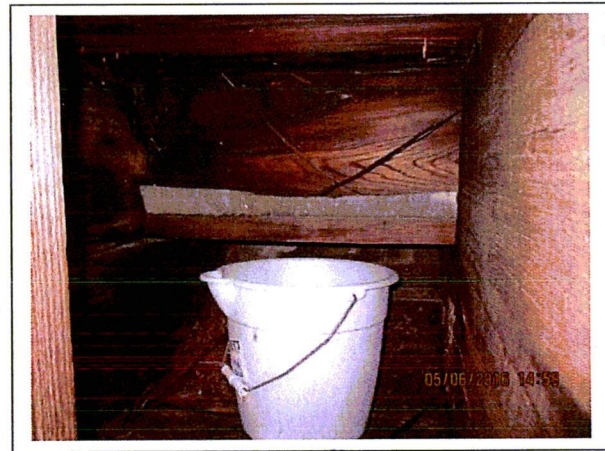
3 - COPPER CLAD CUPOLA BASE AND FLASHINGS

1. The sealant at the top of the Copper Counter Flashing to the Vertical Wood Siding is deteriorated and failed in some locations allowing for a point of water intrusion behind the flashing.

2. The vertical counter flashing leg in some locations is not pulled tight to the back vertical leg of the ledge cover/flashing leaving a large gap (large enough to get fingers up behind). The back leg of the horizontal ledge flashing is only 2-3" high. With a wind driven rain, water can be blown in up behind the counter flashing, over the vertical leg of the ledger flashing and into the building.

3. The copper ledger flashing is in fair to poor condition with very limited to no slope to shed water as observed by the water stains and residue. The soldered joints in the copper ledge flashing are in poor condition and with the standing/ponding water, failed joints will allow water into the building.

4. The wood decking and support framing members at several locations around the cupola, at the underside of the stepped ledge, are water stained and severely rotted/deteriorated or in very poor condition due to leaking over time.

Recommendations: Based on our observations of both the interior conditions of the copper ledge, all existing copper flashings and horizontal decking should be removed. Even though most areas and conditions can be observed from the interior allowing for the generation of a good work scope for the repairs and restoration, a more thorough investigation needs to be conducted of the framing members and surrounding conditions once the copper and decking is removed. All rotted and deteriorated wood framing must be repaired/replace/reinforced as required. New wood decking, tapered to slope and shed water, is needed to eliminate standing water. The installation of a self-adhering waterproof membrane flashing material over the new wood decking should also be installed. Properly installed metal ledge covers and counter flashings, seamed, properly lapped, anchored and sealed will ensure watertight conditions. The counter flashing over the vertical leg of the ledge cover flashing needs to be installed in a manner as to avoid a sealant dependent joint at the top and all vertical legs of flashings must extend high enough to prevent migration of wind driven rains up over the top.

We also recommend a review of all copper by a copper restoration/repair craftsman to help determine if all or some copper components can be salvaged, restored, modified and reinstalled in a manner to provide watertight conditions.

Although copper is the preferred metal for the replacement of any or all components, a galvanized prefinished bronze colored metal may be a less expensive option. Careful detailing and installation to ensure watertight joints along with approval from Mississippi Department of Archives and History (MDAH) will be required in going with a pre-finished galvanized metal.
