November 30, 2016

TO: Madison County Board of Supervisors

SUBJECT: Risk Rating of Trees at Old Courthouse Square in Downtown Canton

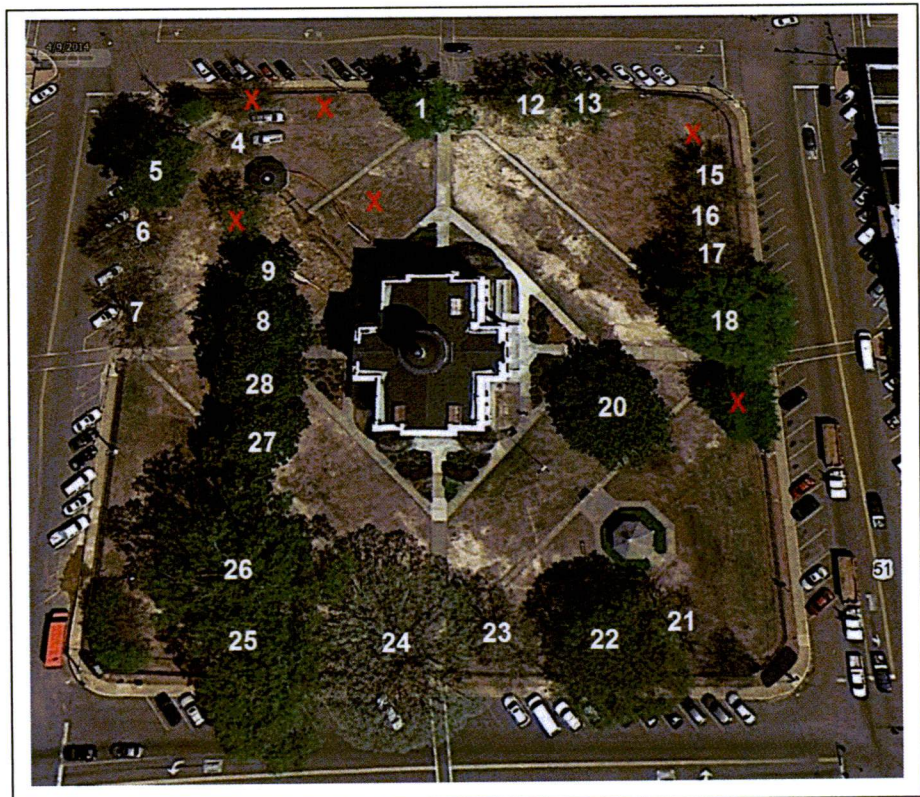
**Tree Health:** A similar tree evaluation was made in 2008 so a general trend of declining tree health could be seen. Six trees have been removed over the past 8 years which represents a 20% loss in tree canopy (red Xs in photo right). Most

of the trees that died were in the northern half of the property. This is where tree replacement is needed. If you want help deciding on species, size, installation and care we are available.

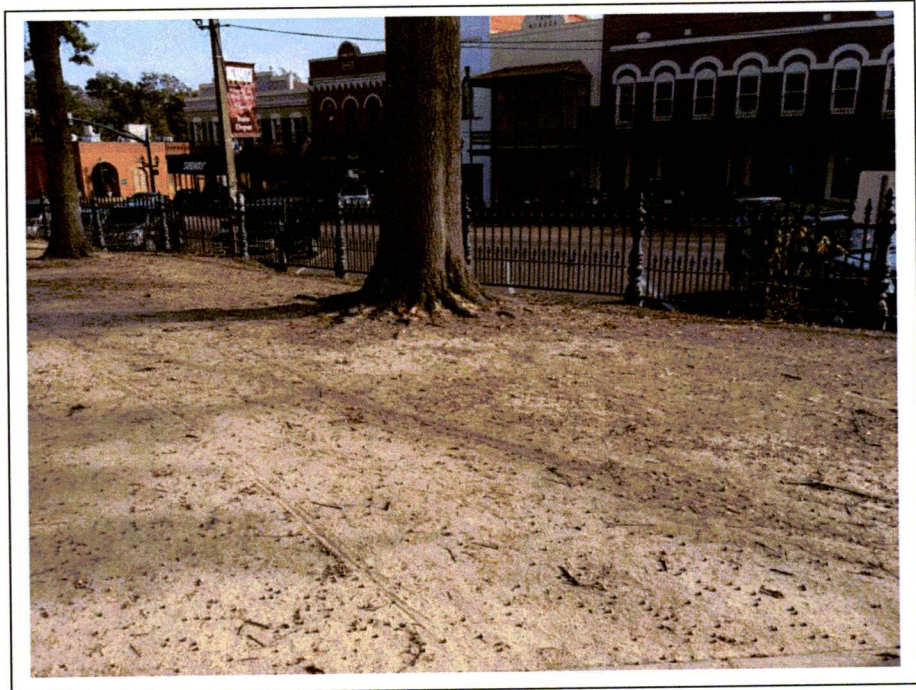
Remaining trees have numerous dying twigs and branches which are a result of declining health. A primarily causal factor is soil compaction which prevents the soil from absorbing, holding and delivering water to tree roots. The soil is in much worse shape and more compacted than it was 8 years ago. Foot traffic around these trees during biennial Canton Flea Markets and annual Christmas in Lights programs and

numerous other events have taken their toll on the soil surface. Dirt patches are getting larger (photo right). The soil in these patches have been reduced to a packed fine dust that repels water and will not support life. It is a muddy mess when it rains. Soil compaction needs to be alleviated dramatically and quickly to prevent further tree health deterioration. The cost of doing nothing to combat soil compaction and improve tree health is escalating. Most the costs and effort to mitigate tree risk problems this year, ex. pruning out twig and branch dieback, are directly linked to poor soil conditions.

Therefore, our general tree health recommendation is to loosen up the soil and improve its ability to absorb and hold water. Any improvement in tree health will reduce future twig and branch dieback. So fighting soil compaction will help achieve a long-term goal of keeping the risk of tree failures to a minimum. A golf course lawn aerator has been found to be effective at loosening up the soil in lawn areas and under trees. Multiple passes of an aerator each year over many years may be needed to turn this soil around. Follow up by applying 2-4 inches of organic mulch under each tree out to at least it's dripline. Mulch will protect the newly aerated soil under trees from future compaction and aid in water infiltration. Organic mulch can be seasoned wood chips, bark, pine needles, etc. Mulch would need to be applied annually. If you wanted to contract this work out, there is a local ISA certified arborist at Madison Garden Center and Landscaping, Trey DeLoach. He may also have a better idea on how to combat soil compaction in the high foot traffic areas. He would also be a great resource for help in replacing lost trees.

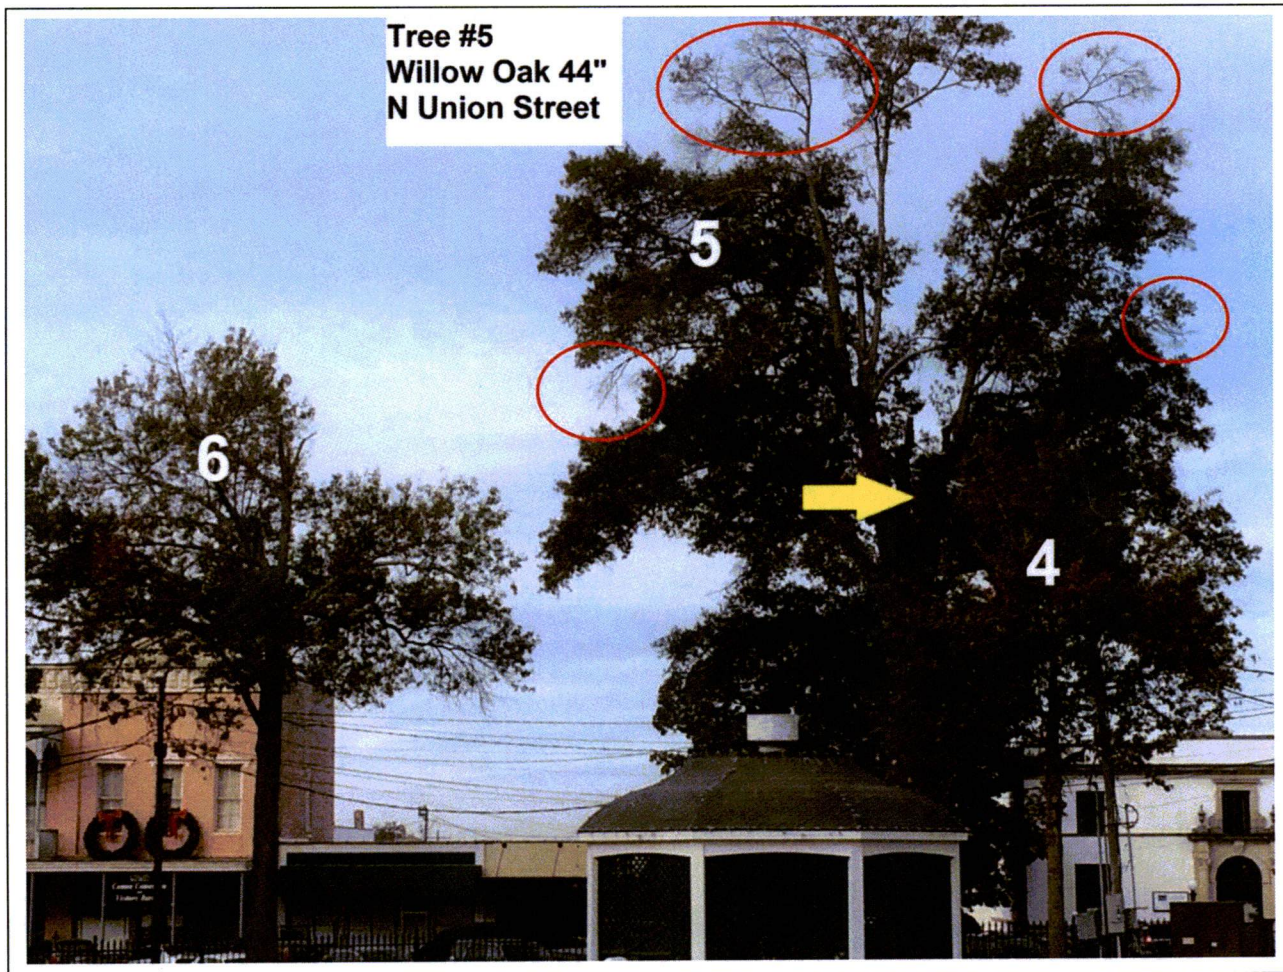
One tree poses a high risk of failure (#5). Twelve trees pose a moderate risk of failure and seven trees pose a low risk. Two trees were judged to be a very low risk. Most of the risk of tree failure can be mitigated by removing dead branches. The lone high risk tree (#5) is recommended for removal.

**#5 poses the highest risk of failure.** This is a Willow oak 44 inches in stem diameter on N. Union Street (photo below). Horse carriages load directly under this tree and the carousel is nearby. Numerous dead branches (red circles) and a large scaffold branch with rot and a cavity (yellow arrow). Soil compaction and health deterioration has compounded the problems of old wind damage. Tree removal is the easiest solution to tree risk. Otherwise drastic pruning will be needed to stabilize the tree. The tree may not be able to recover from that extent of pruning. If the tree is kept, it will likely live only another 4-5 years.

**Tree #5 should be removed by February 2017. Pruning of dead branches should be completed by April 2017. Other mitigation recommendations should be completed within a year.**

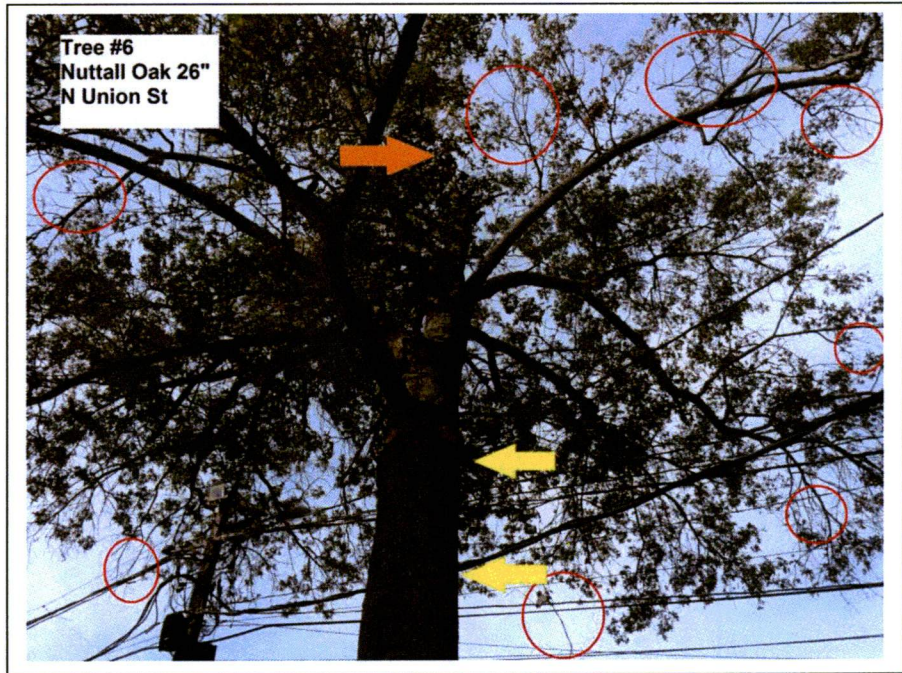
#6 is a Nuttall Oak with a 26-inch stem diameter that is located on N Union Street. Numerous dead branches are located over the street (red circles). Dead snag needs to be removed (orange arrow). Two powerlines are laying directly against the stem (yellow arrows). An energized tree could shock anyone touching the tree. Remove dead branches and dead snag this winter. Insulate or move these powerlines. Foot traffic under trees #5-7 is killing them.

6	N. Union Street	Nuttall Oak	26	60	Dead branches over power line. Powerlines touching tree (could energize tree). Top broken out with dead stub.	Moderate	Deadwood removal. Move powerline away from tree or insulate.	
7	N. Union Street	Nuttall Oak	26	70	Dead branches over power line.	Moderate	Deadwood removal.	401

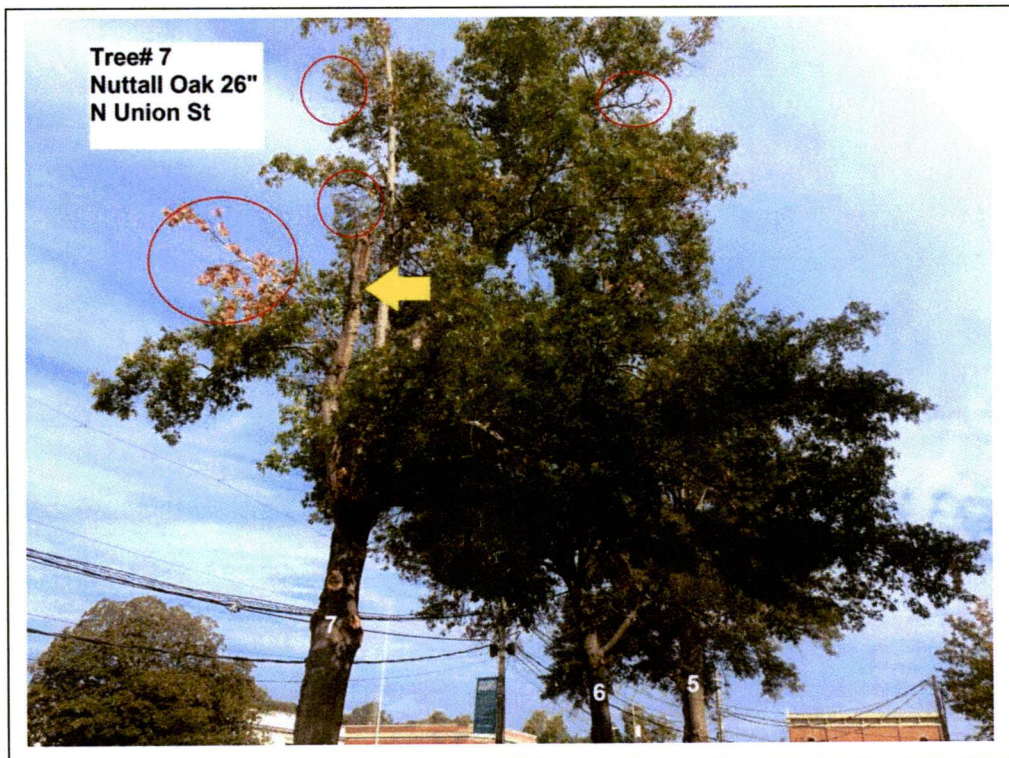
#7 is a Nuttall Oak with a 26-inch stem diameter that is located on N Union Street near the center of the block. Dead branches are located over the street (red circle). A dead snag is also located over the sidewalk (yellow

arrow). Remove dead branches and dead stub this winter.

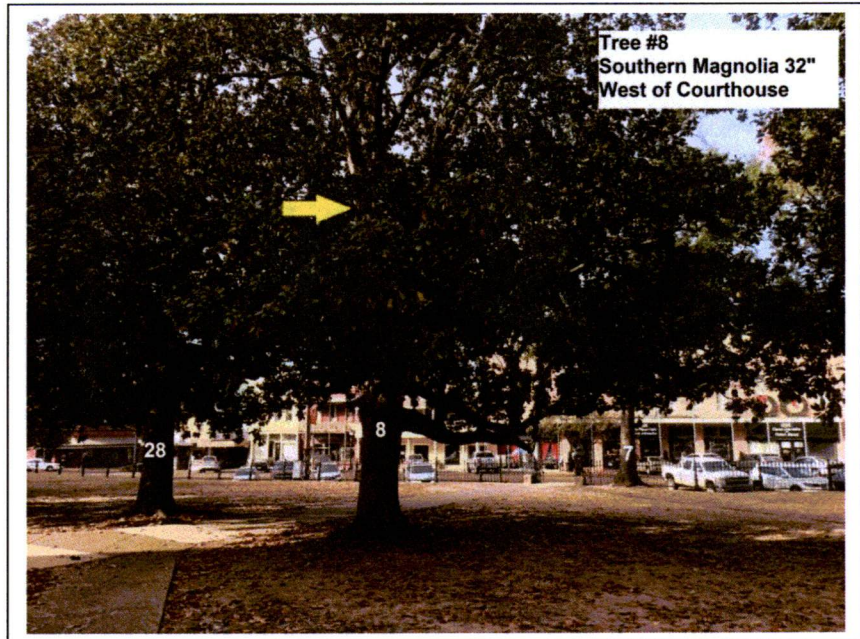
#8 is a Southern Magnolia with a 32-inch stem diameter that is located west of the courthouse. Tree is fairly solid with few problems. An old security light is still up in the tree and could fall (yellow arrow). Foot traffic has destroyed the soil on the west side of the courthouse. Magnolias seem to take this soil compaction better than any of the other trees but the leaves in their crowns are starting to thin out.

8	West of Courthouse	Southern Magnolia	32	60	Old security light poorly attached.	Low	Remove security light.	
9	West of Courthouse	Southern Magnolia	21	55	None	Very Low	None	
12	W. Center Street	Water Oak	13 and 15, 2 stems	50	Dead limb over street, dead branch on west side over sidewalk.	Moderate	Remove deadwood. Move electric box and wires from tree.	418
13	W. Center Street	Water Oak	22	45	Dead branches over lawn area.	Moderate	Remove deadwood.	
15	N. Liberty Street - Hwy 51	Cherrybark Oak	20	45	Dead branches.	Low	Remove deadwood.	422
16	N. Liberty Street- Hwy 51	Cherrybark Oak	19	50	Dead branch stubs.	Low	Remove deadwood.	423
17	N. Liberty Street- Hwy 51	Cherrybark Oak	18	60	Nearly 25% of branches are dead.	Moderate	Remove deadwood.	424
18	N. Liberty Street - Hwy 51	Water Oak	33	75	Dead branches	Low	Remove deadwood. Prune to reduce crown size.	425
20	SE corner of Courthouse	Southern Magnolia	31	45	Dead branches	Low	Remove deadwood and reduce crown size.

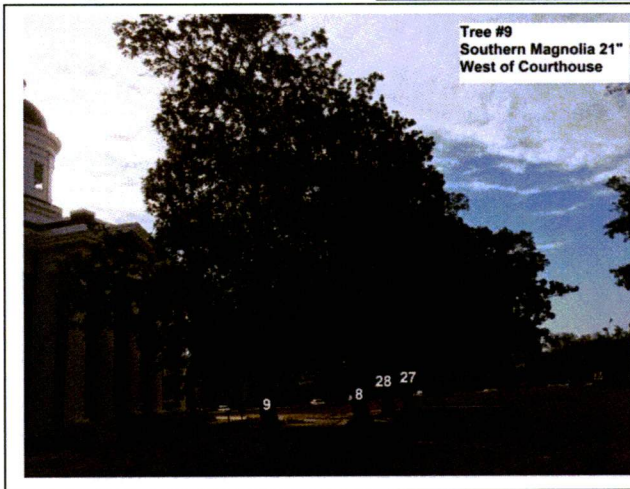
#9 is a Southern Magnolia with a 21-inch stem diameter that is located on west of the courthouse. No risk factors were found on this tree.

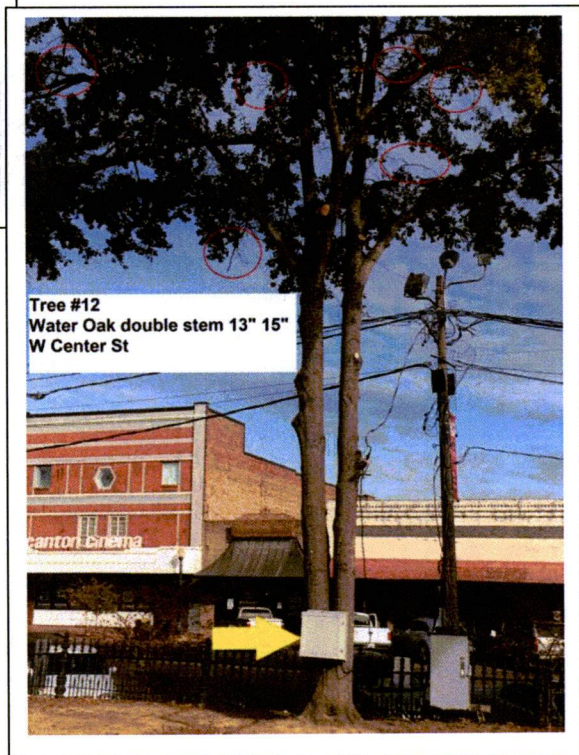
#12 is a Water Oak with two stems, 13 and 15 inches in diameter. It is located on W. Center Street near the center of the block. There is an electrical box attached directly to the tree, this needs to be moved to a post (yellow arrow). Plumbing work has damaged much of the root system. Not sure how tree will respond to further root damage. Dead branches are located over the street (red circles). Remove dead branches this winter.

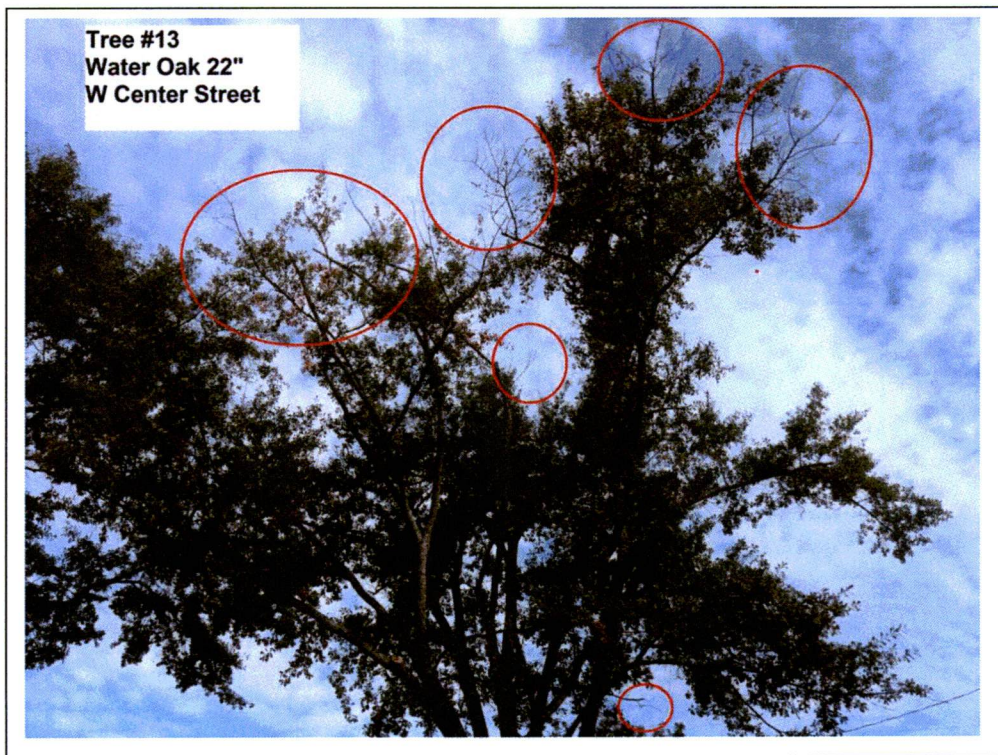
#13 is a Water Oak with a 22-inch stem diameter that is located on W. Center Street. Dead branches are primarily located over lawn area (red circles). Remove dead branches this winter.

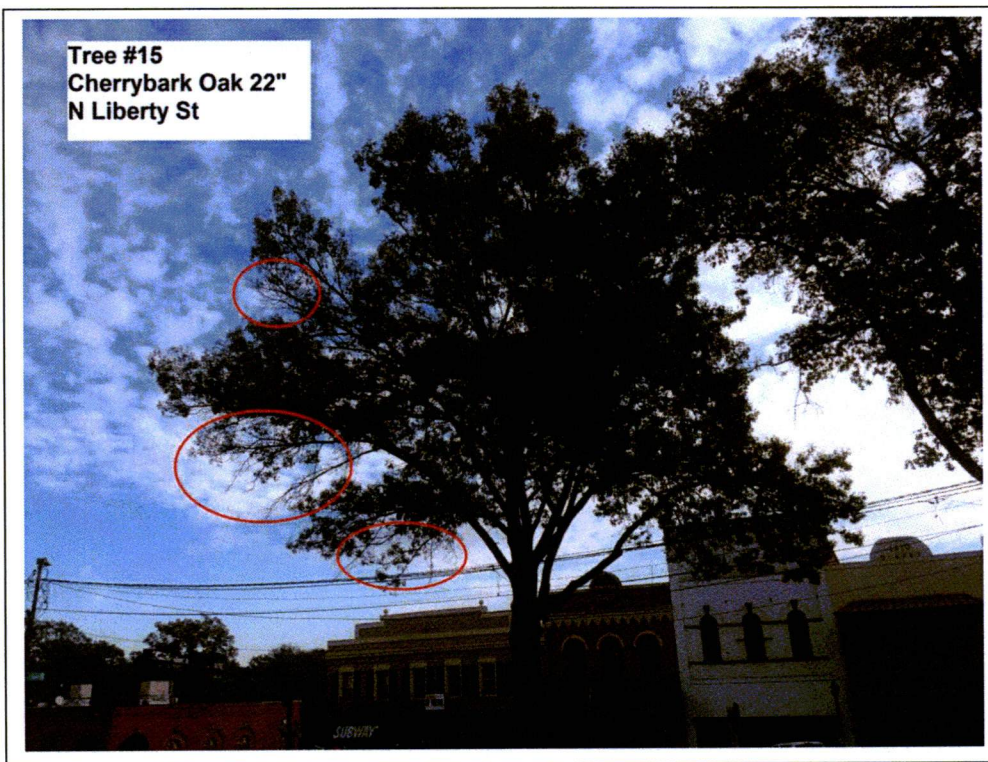
#15 is a Cherrybark Oak with a 20-inch stem diameter that is located on N. Liberty Street – Hwy 51. Dead branches are located over the street and lawn area (red circles). Remove dead branches this winter.

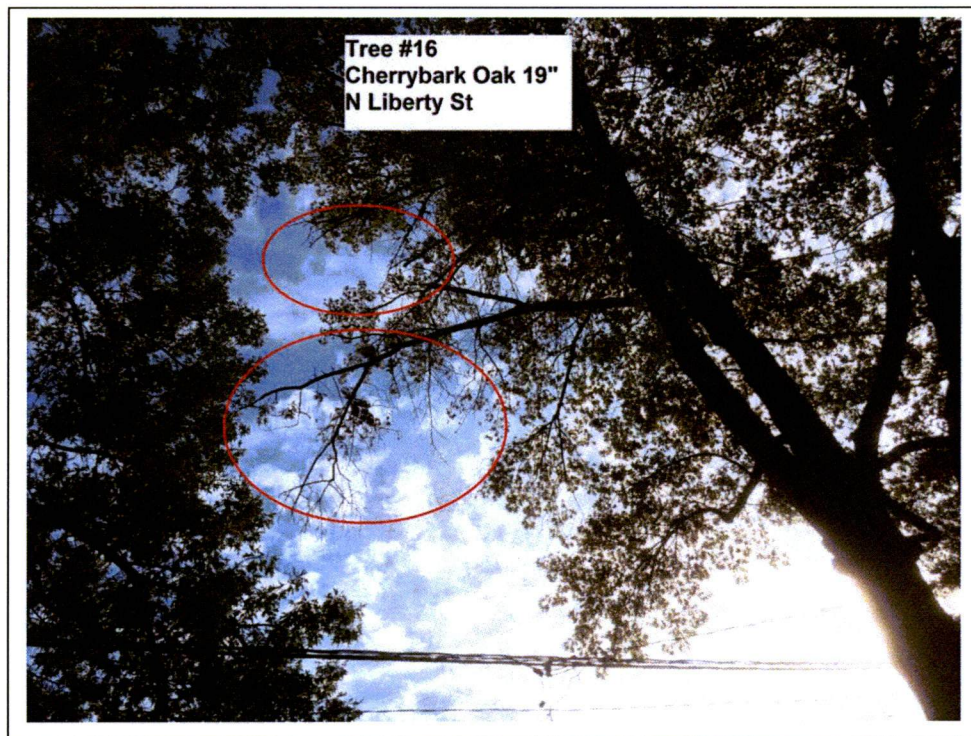
#16 is a Cherrybark Oak with a 19-inch stem diameter that is located on N. Liberty Street – Hwy 51. Dead branches are located over the street (red circles). Remove dead branches this winter.

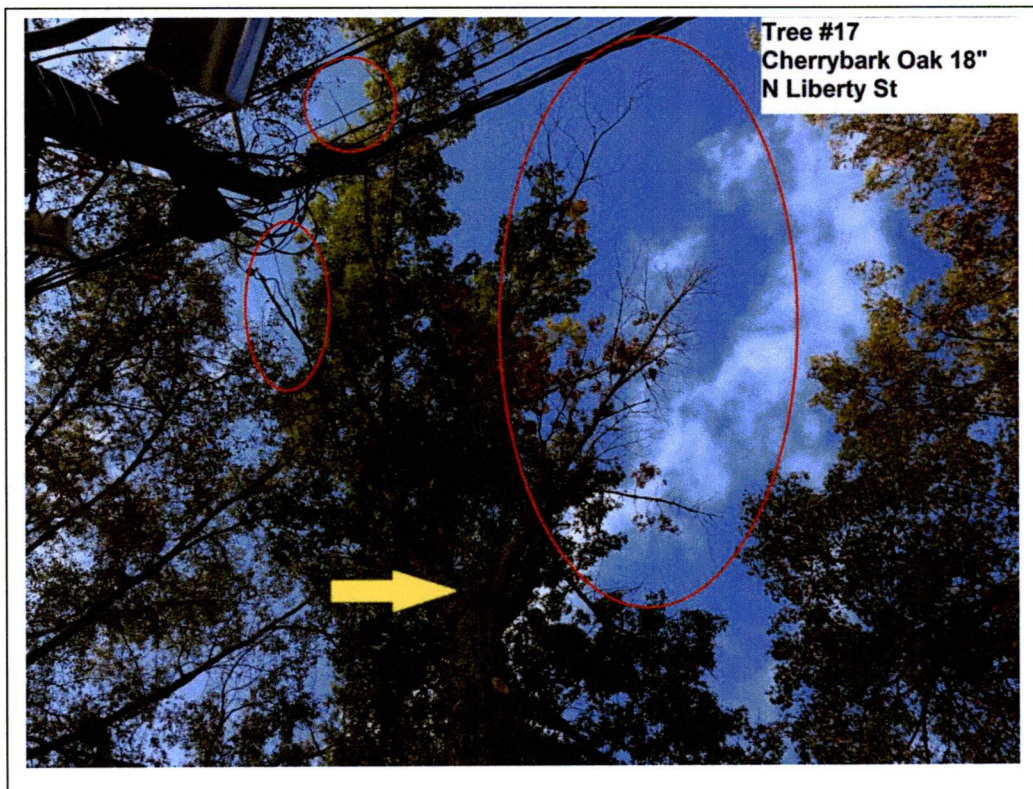
#17 is a Cherrybark Oak with an 18-inch stem diameter that is located on N. Liberty Street – Hwy 51. Nearly 25% of its branches have recently died (red circles). An old top snapped out in the

past, so monitor this area (yellow arrow). Remove dead branches this winter.

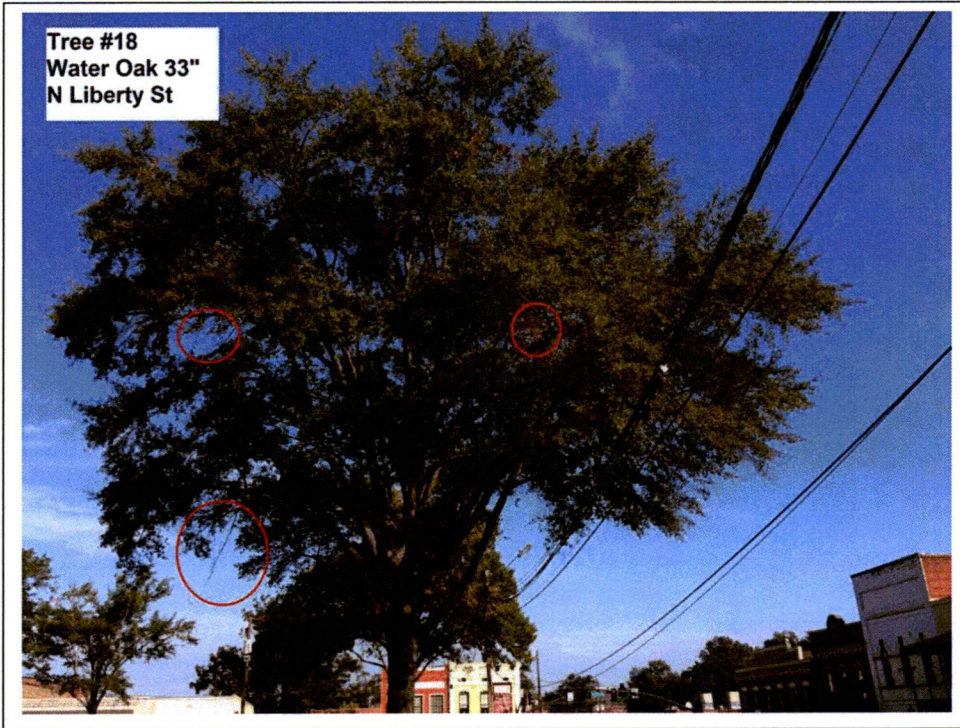
**Tree #18**  
**Water Oak 33"**  
**N Liberty St**

#18 is a Water Oak with a 33-inch stem diameter that is located on N. Liberty Street – Hwy 51. Dead branches are located over the street (red circle). Remove dead branches this winter.

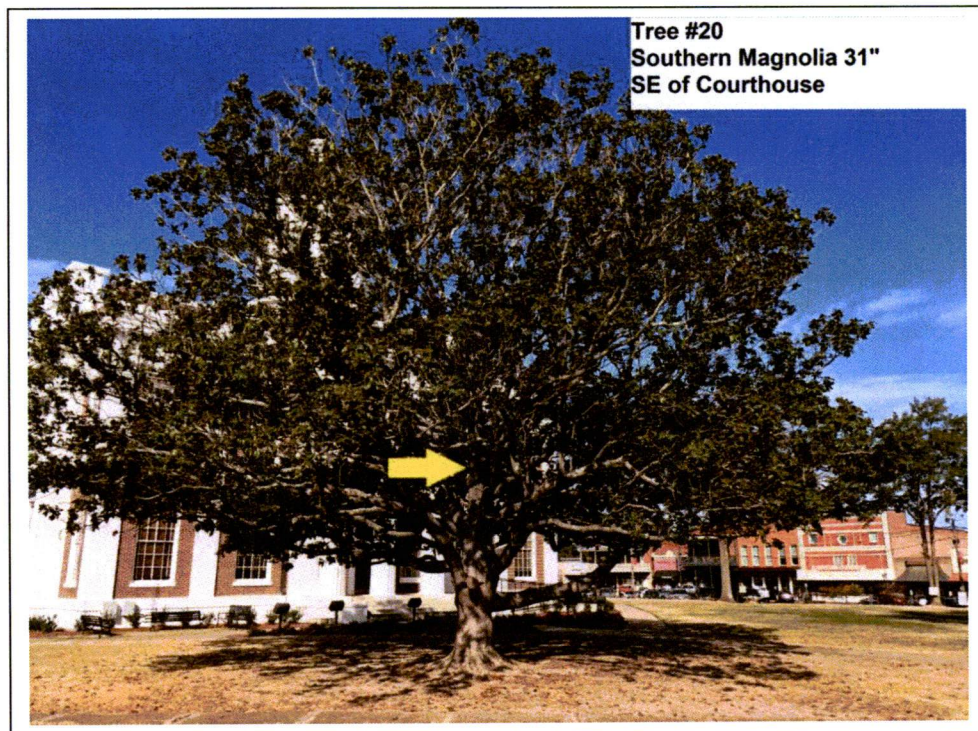
**Tree #20**  
**Southern Magnolia 31"**  
**SE of Courthouse**

#20 is a Southern Magnolia with a 31-inch stem diameter that is located on southeast of the courthouse. Dead branches are starting to accumulate as tree health declines. Foliage is become sparse. Look at soil around tree to see why. Remove large dead branch (yellow arrow).

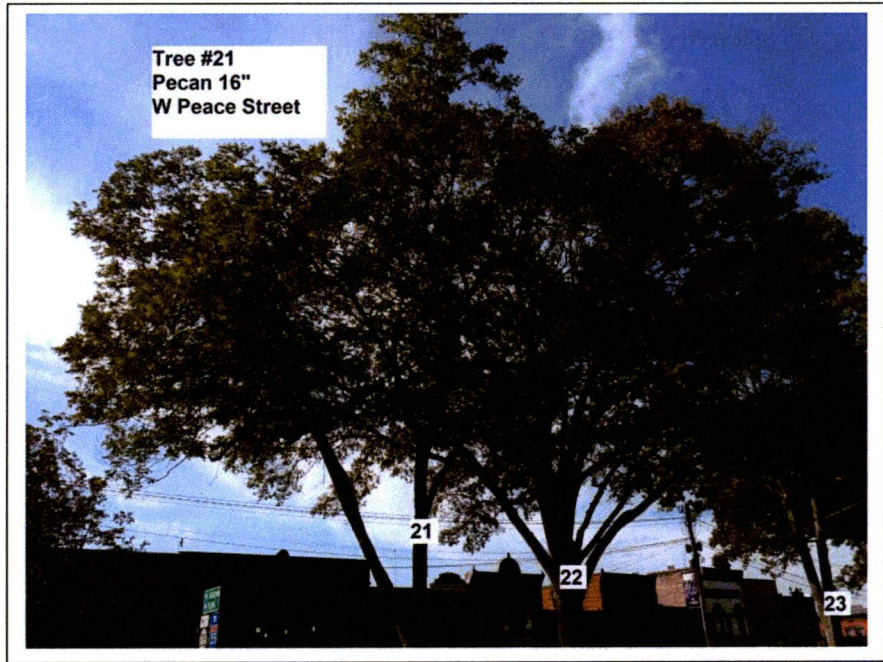
#21 is a Pecan with a 16-inch stem diameter that is located on W. Peace Street – Hwy 22. Tree looks healthy and no risk problems were found.

21	W. Peace Street - Hwy 22	Pecan	16	50	None	Very Low	None	
22	W. Peace Street - Hwy 22	Water Oak	39	60	Dead branches over lawn area.	Moderate	Remove deadwood.	433
23	W. Peace Street - Hwy 22	Cherrybark Oak	24	75	Dead branches over sidewalk and powerlines.	Moderate	Remove deadwood.	434

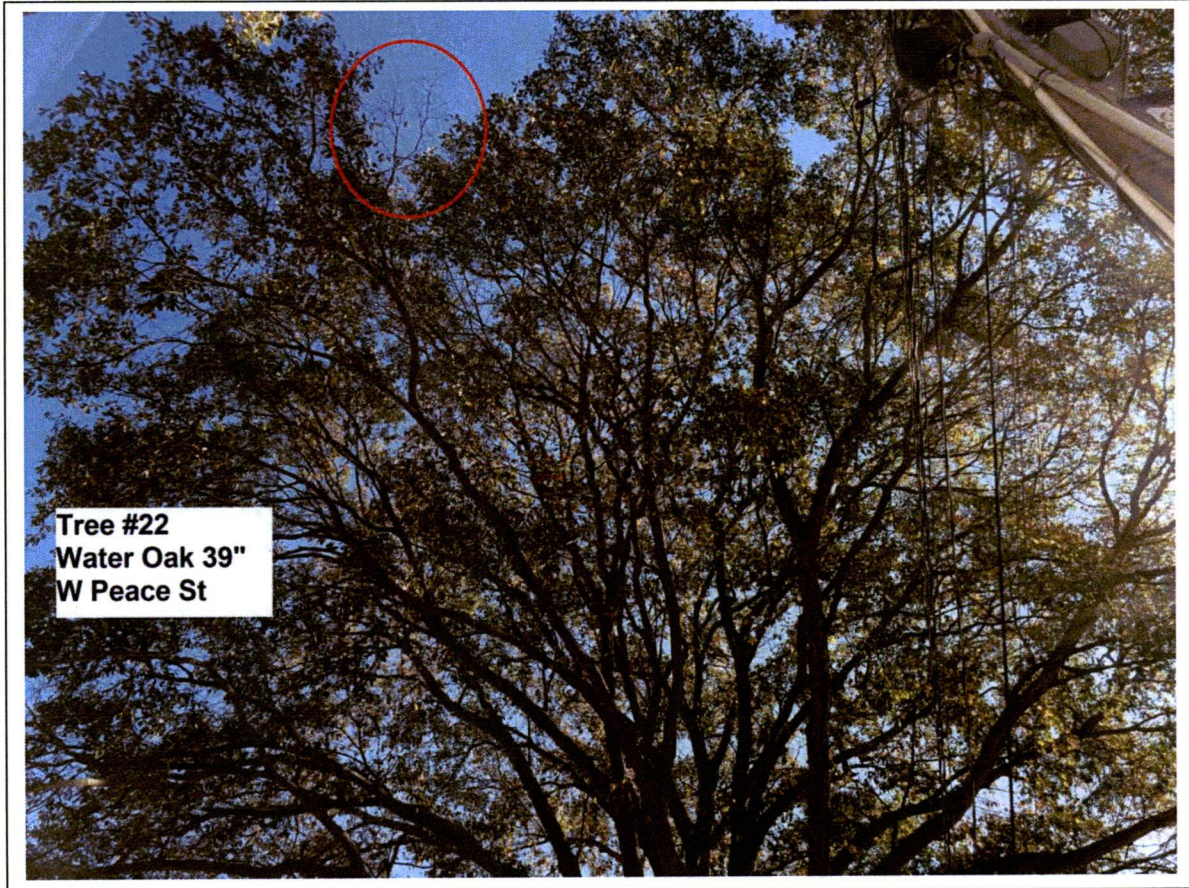
#22 is a Water Oak with a 39-inch stem diameter that is located on W. Peace Street – Hwy 22. A few dead branches are located over the lawn area (red circle). Remove dead branches this winter.

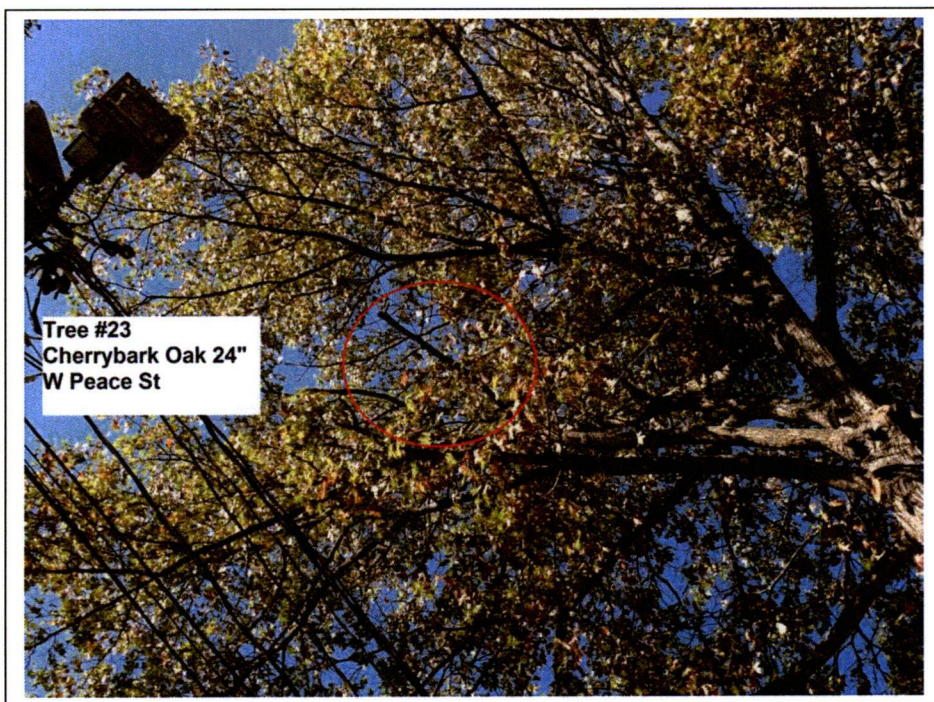
#23 is a Cherrybark Oak with a 24-inch stem diameter that is located on W. Peace Street – Hwy 22. A few dead branches are located over the street and powerline (red circle). Remove dead branches this winter.

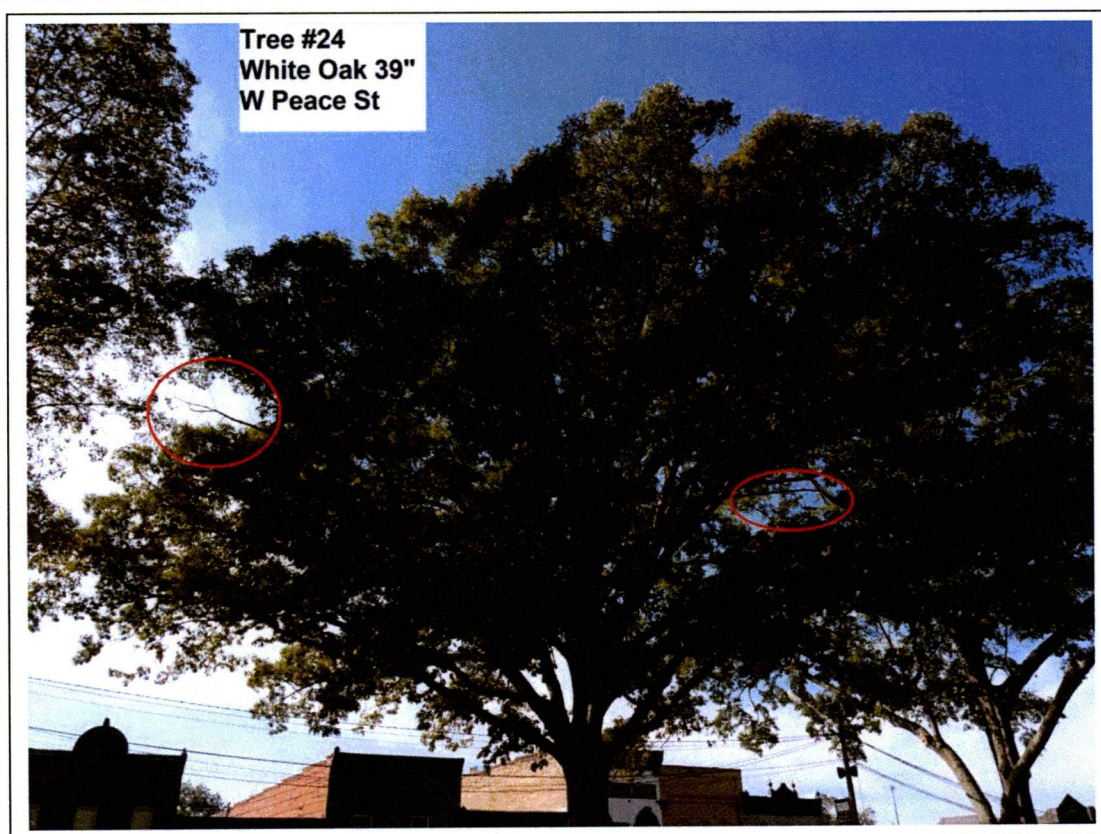
#24 is a White Oak with a 39-inch stem diameter that is located on W. Peace Street – Hwy 22. A few dead branches

are located over the street and lawn areas (red circles). Otherwise a very healthy tree. Remove dead branches this winter.

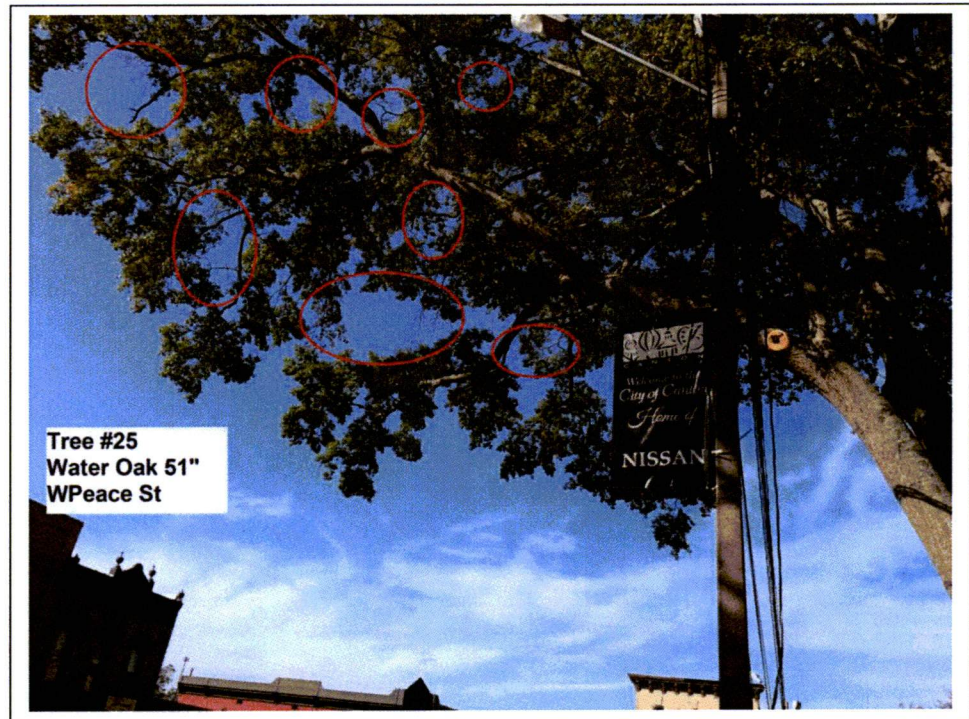
#25 is a Water Oak with a 51-inch stem diameter that is located on W. Peace Street – Hwy 22. Dead branches are located over the street (red circle). Remove dead branches this winter.

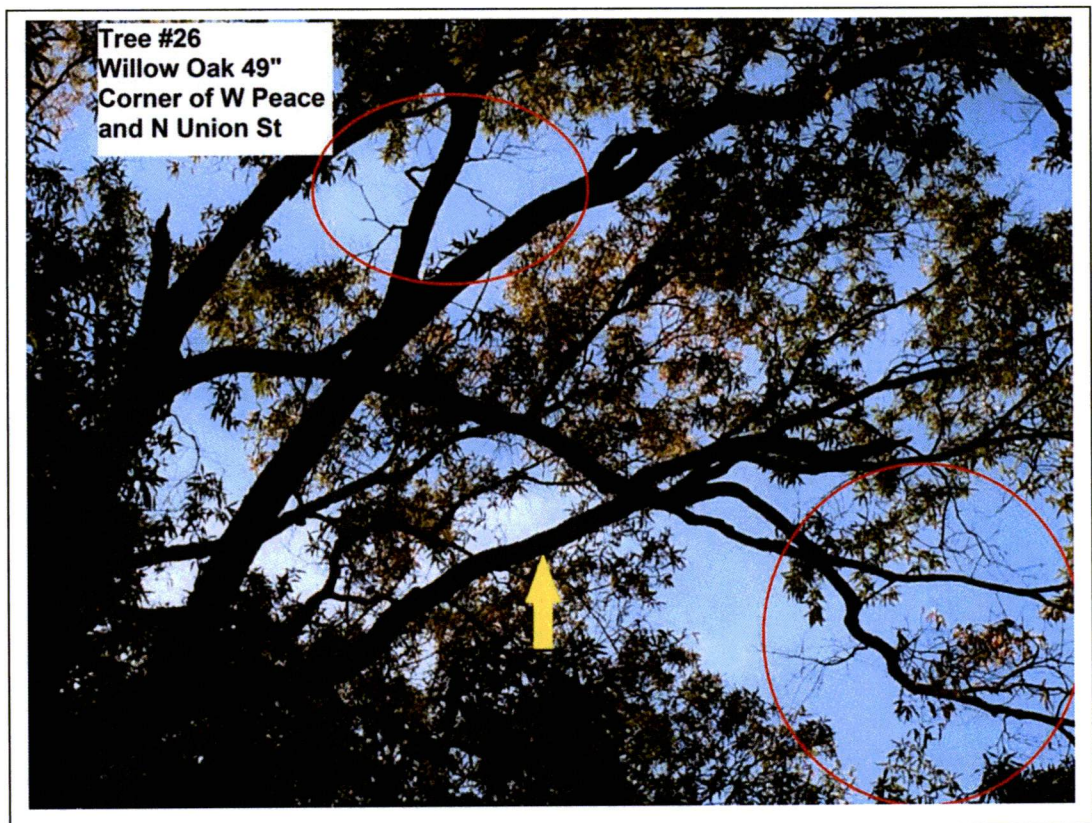
#26 is a Willow Oak with a 49-inch stem diameter that is located on N. Union Street, southwest of courthouse. Dead branches (red circles) and large dead stubs (yellow area) are located over lawn area. Remove them this winter.

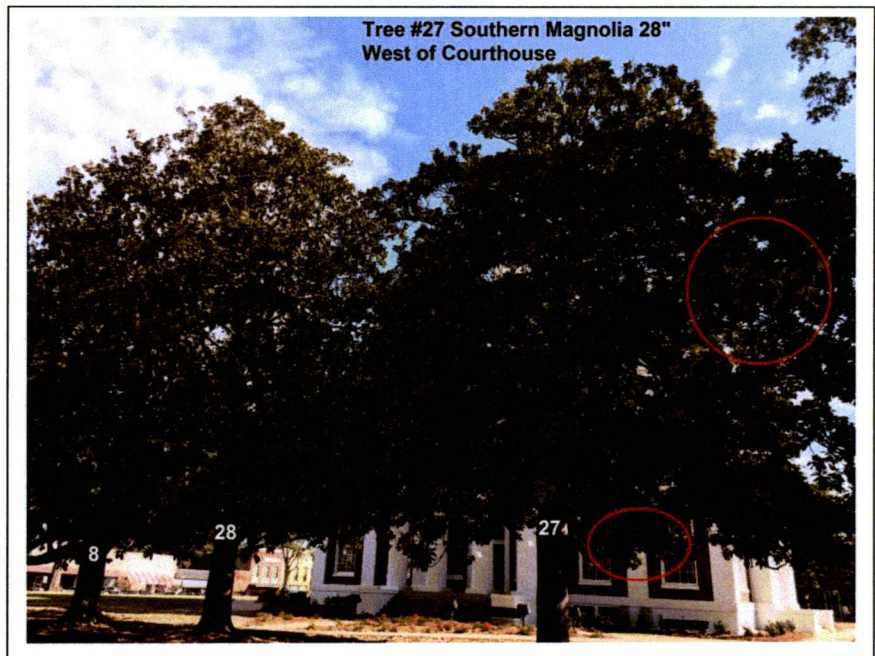
#27 is a Southern Magnolia with a 28-inch stem diameter that is located west of courthouse. Dead branches are located over the lawn area (red circle). Remove dead branches this winter.

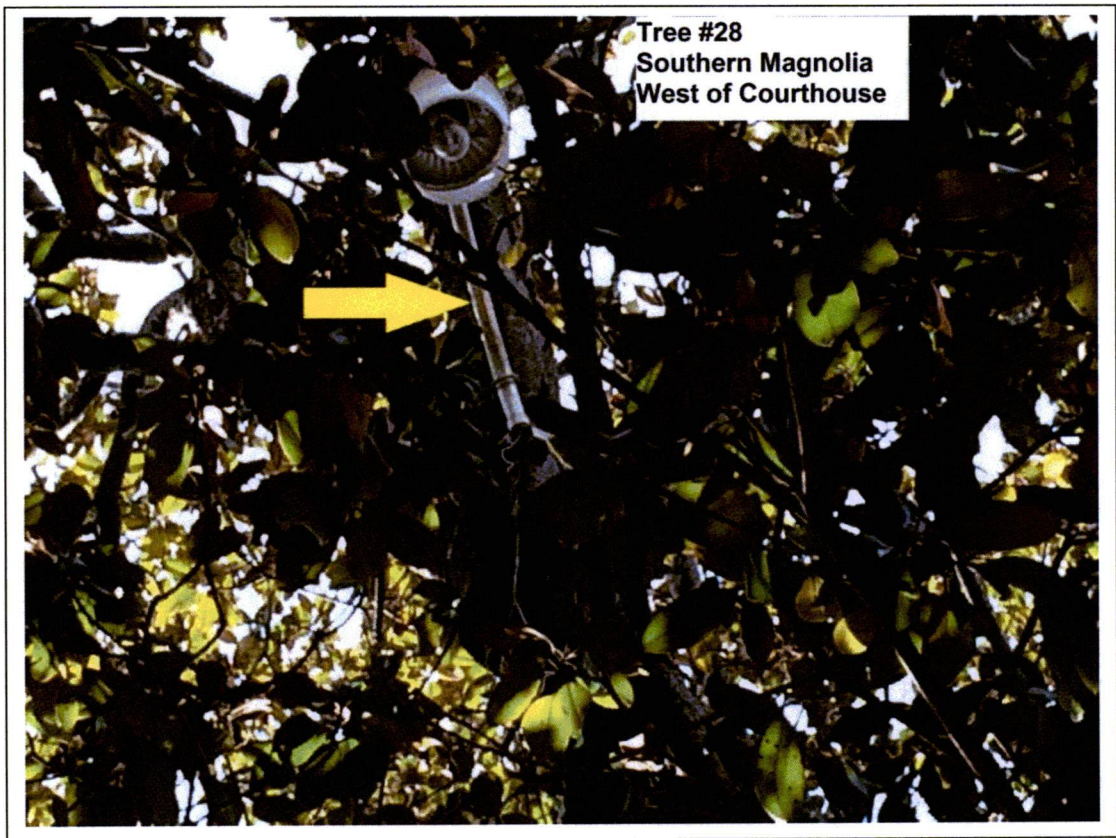
#28 is a Southern Magnolia with a 28-inch stem diameter that is located west of courthouse. The tree has a few broken branches that should be removed. Of highest concern is an old security light still stuck up in the tree. This light needs to be removed.
