Change Order

PROJECT: *(Name and address)*
1208.3- Madison County Courthouse-
Cupola Repairs and Restoration
Canton, MS

FIELD REPORT No FR3

Field Report No. 6

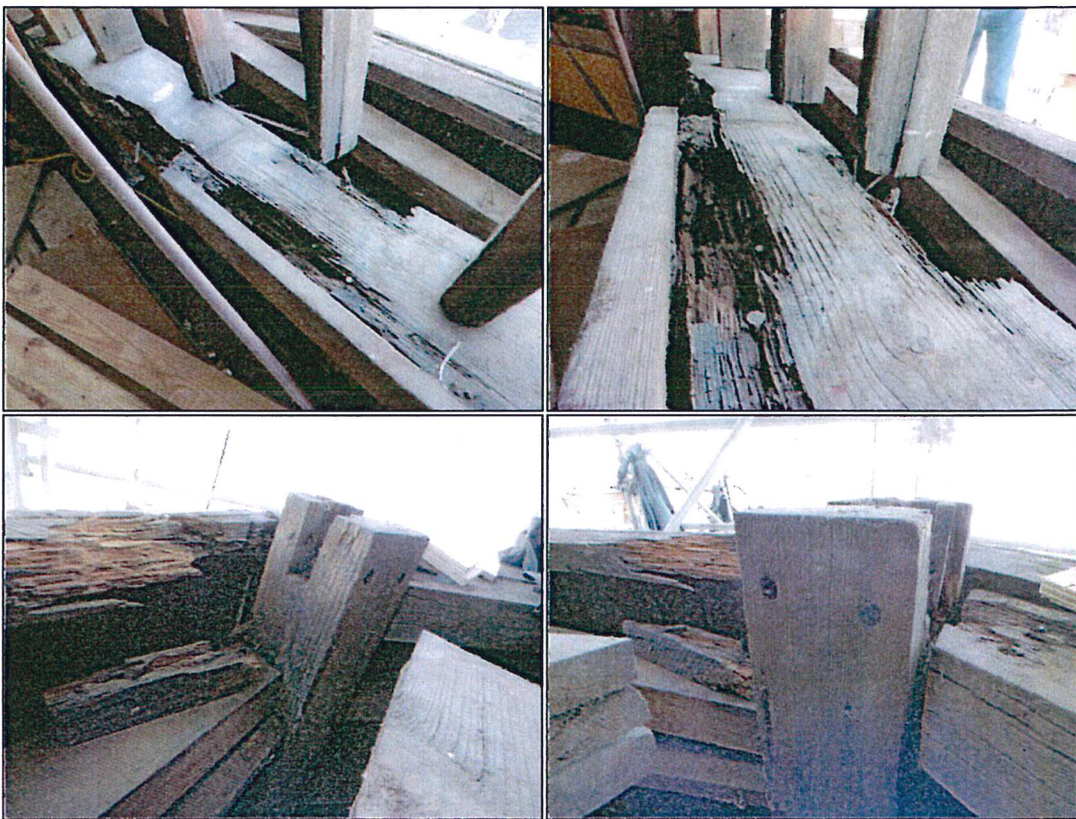
Figures 1 – 4

There are two sets of beams along the outer perimeter. The original “curved beam”, some of which had been replaced years ago, and a straight “outer beam.” The area of reported concern involved the north side where heavy deterioration was found along three of the “curved beam” sections. This damage had been hidden from view until the dismantling of the

outrigger brackets and removal of the outer skin. There were also two sections of “outer beams” that were damaged. One involved a section that had previously been replaced with a 4x6 timber that had deteriorated and collapsed. The other involved the original 6x8 “outer beam” that had deteriorated only at the very end connection to the column, but had also dropped at the column interface. The 4x6 beam had dropped at least 12 inches while the end of the original 6x8 had dropped about 6 inches or so. The upper end of the support column at that location was also deteriorated and split. Another area of reported concern involved highest beam level where the short rafter tails were bearing. Many of the original beams along the perimeter had previously been “repaired” by adding sections of wood blocking along the lower and side faces. This covered deteriorated sections of the original wood beams.

Figures 1 & 2: Discovered heavy deterioration to “curved beam section.” Figures 3 & 4: 4x6 “outer beam” on left side of column has completely collapsed. Original 6x8 “outer beam” on right side has deteriorated at end tenon joint and has dropped about 6 inches.

The three “curved beam” sections at the locations shown below will need to be replaced as the deterioration discovered was much worse than anticipated. We recommend using a doubled 16” wide LVL beam at each location. The collapsed 4x6 “outer beam” will need to be removed and replaced with a tripled 9-1/4” LVL beam. The beam can be cut to a narrower width if needed for assembly. The original 6x8 “outer beam” can be lifted back into place and secured to the column by adding the vertical 2x8 wood blocking attached to the side of the column and directly underneath the 6x8 for support. This same 2x8 blocking should also be installed under both ends of the tripled 9-1/4” LVL beam. The 2x8 vertical blocking was shown on the original contract drawings.

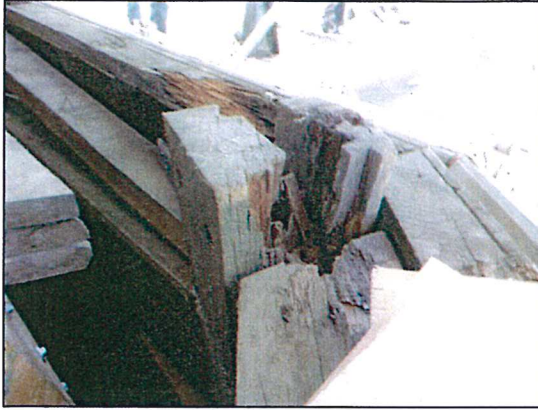
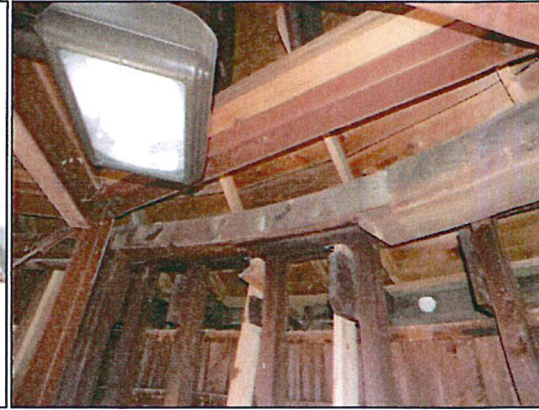
Figure 5: Upper section of support column at intersection of “outer beams” has deteriorated and split at original mortise joint. Figure 6: Upper beam at roof level has deterioration behind and above the blocking repairs that were made during a previous project.

The roof beam level with deterioration has been in that condition for an extended period of time. The last renovation provided some repairs by adding the blocking as previously described. Frankly, the repairs were poorly implemented and mainly covered up the problems rather than properly correcting them. Thankfully, the beam at this level carries very little weight. While the past repairs were incorrectly done, the area is not in structural jeopardy. Regardless, implementing proper repairs while a general contractor is already on site and performing similar repairs elsewhere would seem prudent for the county to consider.

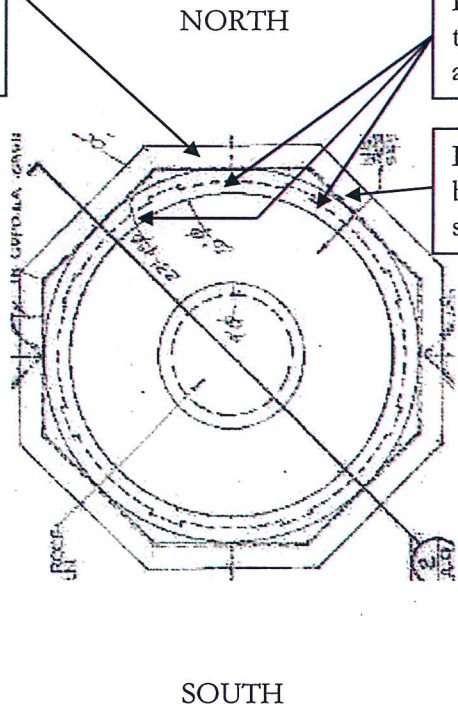
BASIC FRAMING REPAIR PLAN

Damaged "curved beams" at
these 3 locations to be removed
and replaced.

Replace 4x6 "outer beam" w/
triple 9-1/4" LVL. Install
support blocking under both
ends.

Lift the left end of 6x8 "outer
beam" to original position. Install
support blocking underneath end.

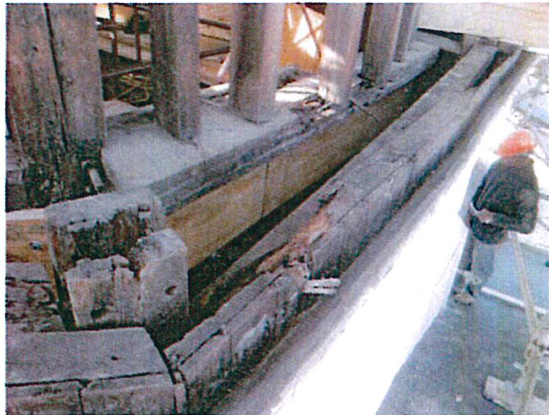
3. During the Course of Restoration, HRY came across areas of severely deteriorated structural wood components in and around the cupola (Primarily in the vicinity of the beams/structure carrying the stepped outriggers). Much of the deterioration could not be seen or observed and extent of damage could not be determined until each section was dismantled and exposed. **Figures 2-5**. There is an inner beam and outer beam supporting the outriggers. Most of the Original Vertical T&G was deteriorated and could not be used. **Figure 6**. Most of the deterioration has occurred at the base of the siding where it was previously discovered the metal transition flashing was installed incorrectly with a reverse lap at the base allowing moisture to accumulate at the base of the siding, which in turn rotted the wood.

Figure 2 – Deteriorated Column and Beam Failure

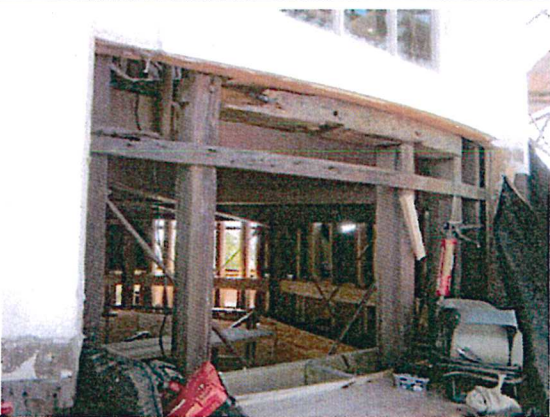
Figure 3 – Damaged Sill Beam

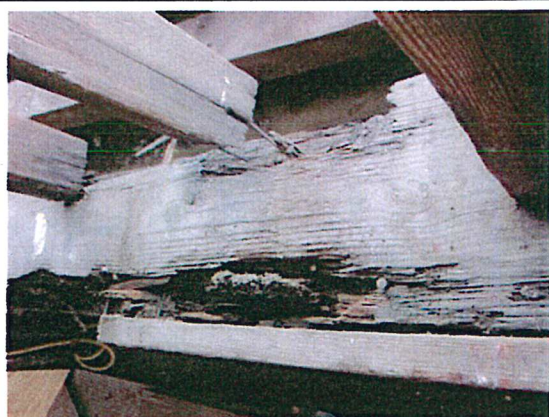
Figure 4 – Damaged Sill Exposed

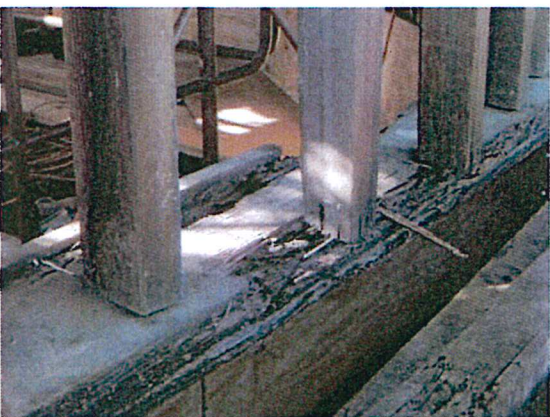
Figure 5 – Deteriorated Sill Beam

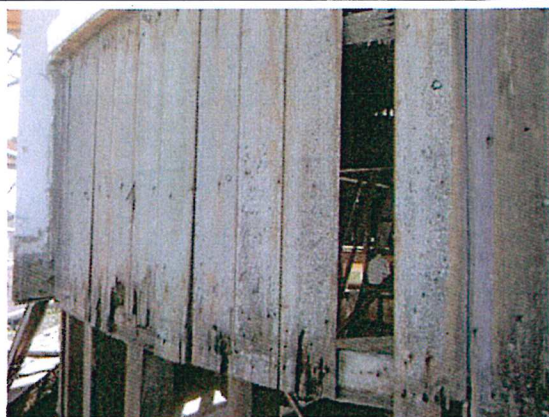
Figure 6 – Deteriorated Original Wood Siding

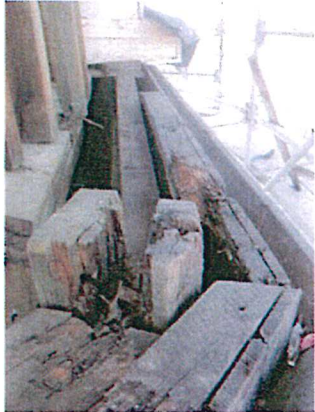
- b. Beams and Window Sills at a couple locations were “internally” damaged.
 - c. Beam ends and connections to columns had deteriorated and failed, thus the beam dropping from the column. **Figure 7**

Figure 7 – Failed Column/Beam Connection

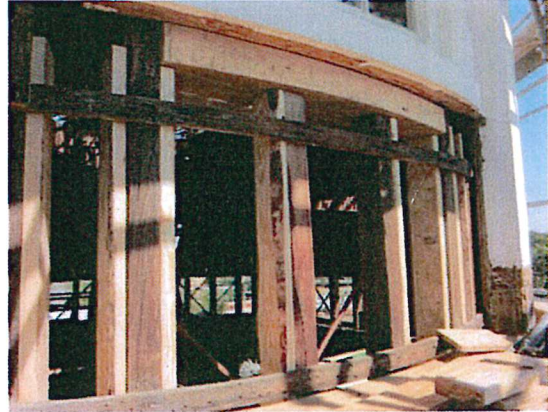
Figure 8 –Horizontal Bands

- d. Horizontal radiused bands will be reused, reinforced or replaced as required with an additional band being installed at the mid-point for additional stability and backer for vertical siding. **Figure 8**

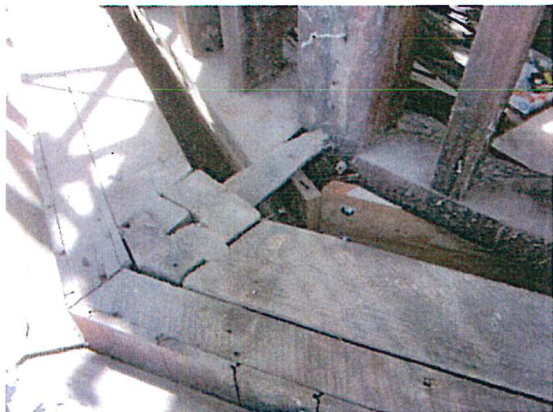
- e. Many of the original joint connections are mortised and tenon with wood pegs. **Figure 9**
 - f. Upon receipt of Structural Engineer’s Report, PCG will prepare and submit Proposal for the Materials and Labor required for repairs and replacement of the Deteriorated Members.

Figure 9 – Original Beam/Column Joinery Detailing

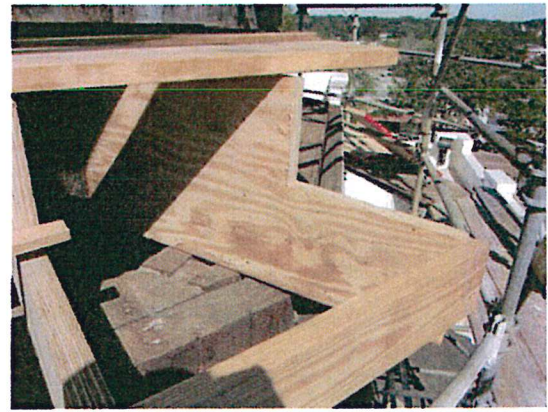
5. HRY indicated a benchmark point was set and the tops of all of the outriggers will be consistent. Some variation and the lower portion may occur due to existing conditions. These variations will be minimized as best possible and will not be visible in the overall appearance of the Cupola upon completion. **Figure 10**

Figure 10 –Stepped Outrigger Installation

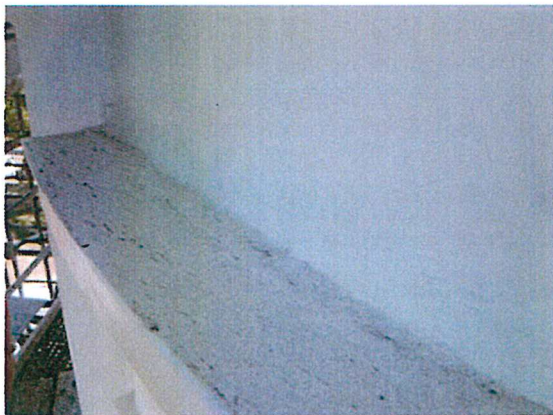
7. Window "Eyebrow" flashing head detail was reviewed and found acceptable. Additional layer of reinforcing may yet be considered. **Figure 11**
8. It was observed that the metal flashings at the base of the Large "Pilasters" were cut in/grooved into the base of the wood. **Figure 12**

Figure 11 – Window "Eyebrow" Flashing

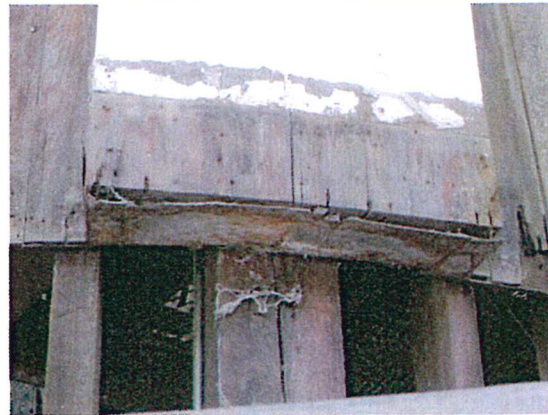
Figure 12 – Wood Pilaster Cut-In for Flashing

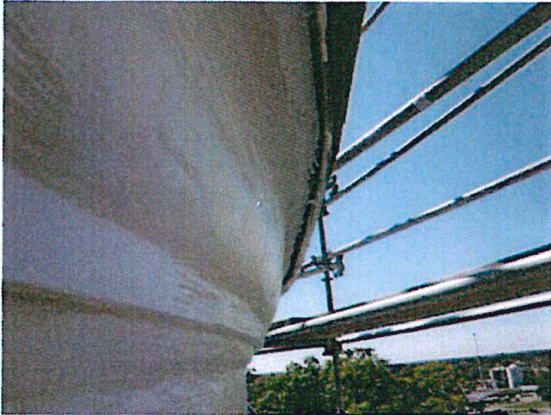
Figure 13 – Base of Roof Flashing to be Sealed

9. Gap under the Copper Dome Base Flashing at the roof edge will be filled with sealant. Any gap larger than ¼", backer rod will be installed. Any roofing felt hanging out will be cut back prior to sealant installation. **Figure 13**

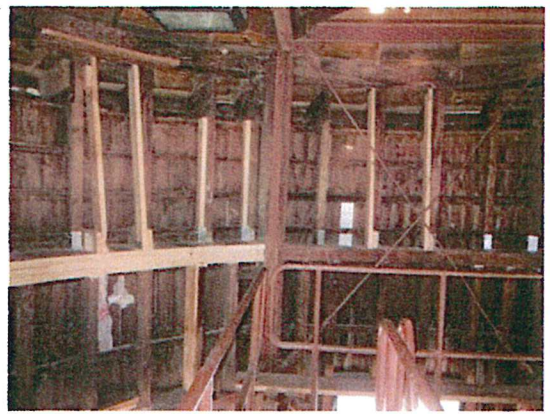
Figure 16 –Interior Structural Repairs
