**MADISON COUNTY BOARD OF SUPERVISORS
MADISON COUNTY, MISSISSIPPI**

**WARNOCK BUILDING REPORT
158 WEST CENTER STREET
CANTON, MISSISSIPPI**

Date: APRIL 20, 2018

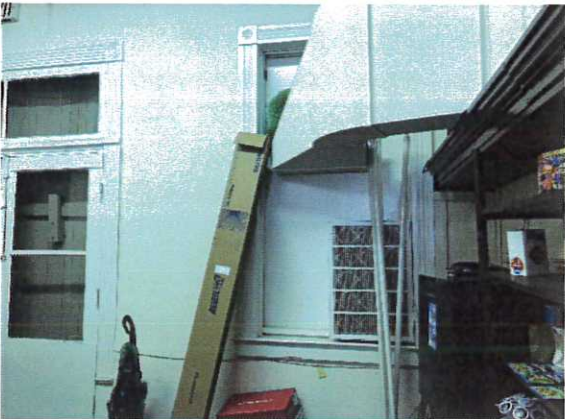
4.5 FIRST FLOOR EXPOSED HVAC DUCT

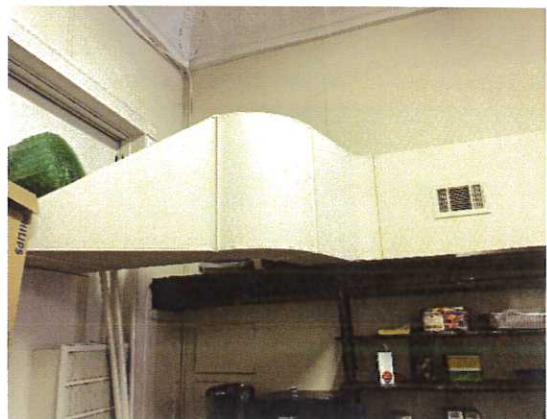
4.6 FIRST FLOOR HVAC EXPOSED DUCT

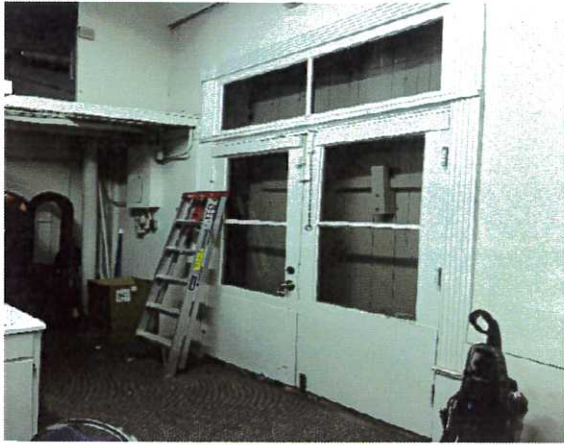
4.7 BLOCKED FIRST FLOOR EGRESS

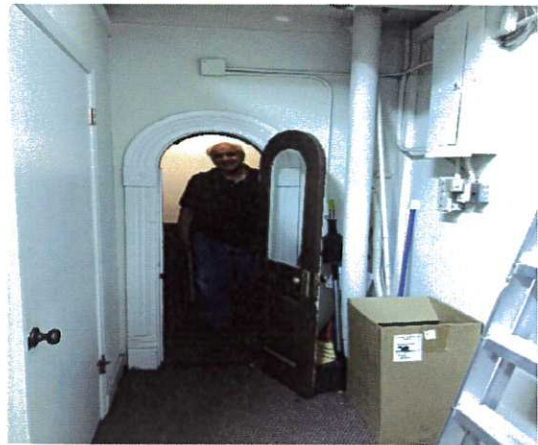
4.8 NON-COMPLIANT FIRST FLOOR DOOR

The main floor also had a very narrow and short door that opened into the back stair. The door is inadequate for exit access and is currently the only exit access door for the back of the main floor. Archives and History may have an issue with modifying this door for proper exit access.

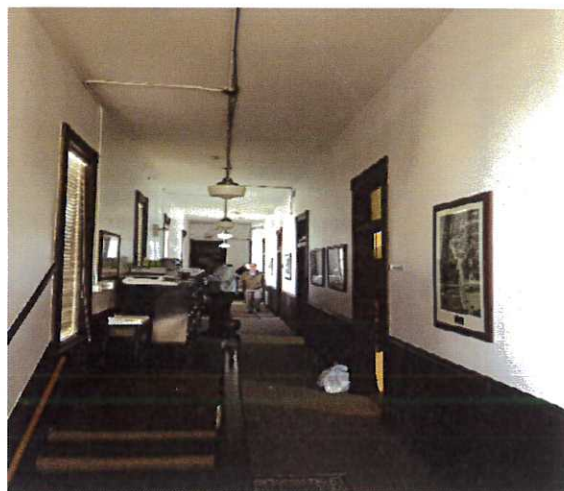
4.11 SECOND FLOOR UNLEVEL CORRIDOR

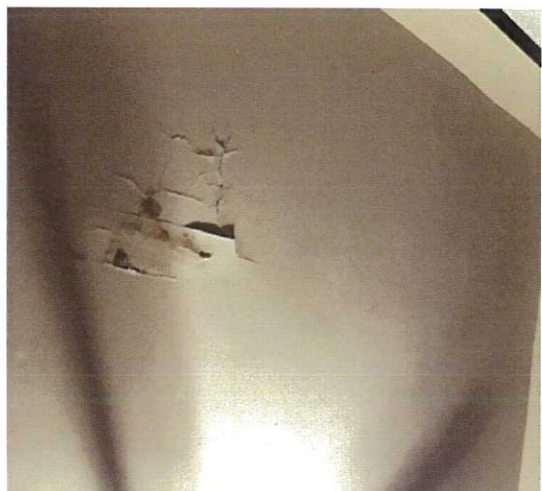
4.12 SECOND FLOOR CEILING LEAK

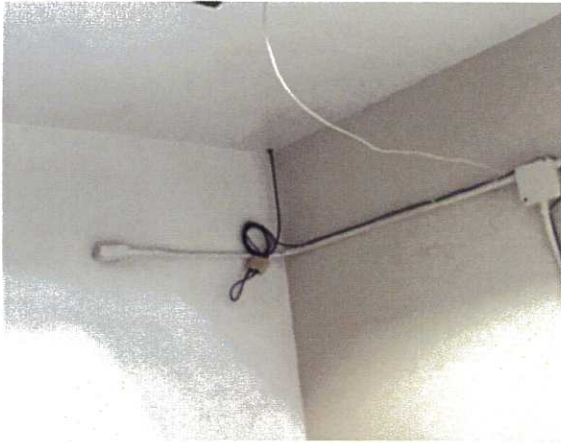
4.13 EXPOSED ELECTRICAL CONDUIT

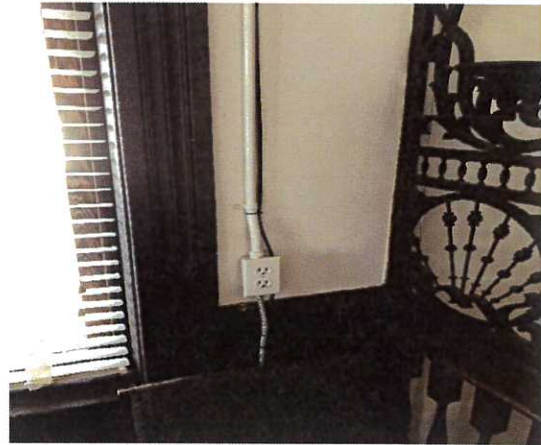
4.14. EXPOSED ELECTRICAL CONDUIT

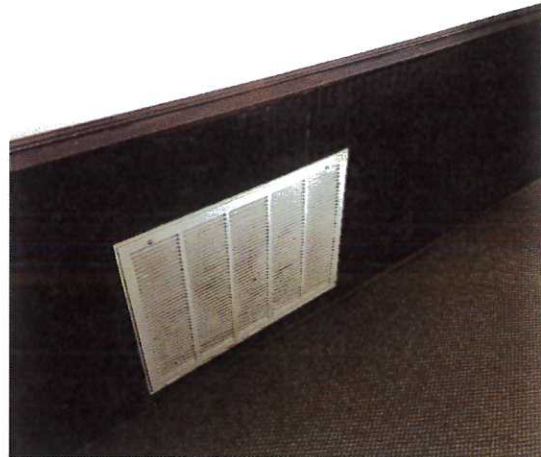
4.16 NON-COMPLIANT RETURN AIR IN HALL

- d. Install return air ductwork (or series of transfer grilles) such that the exit corridor is not used as the return air path.
 - e. Replace all air distribution devices (grilles, registers and diffusers).

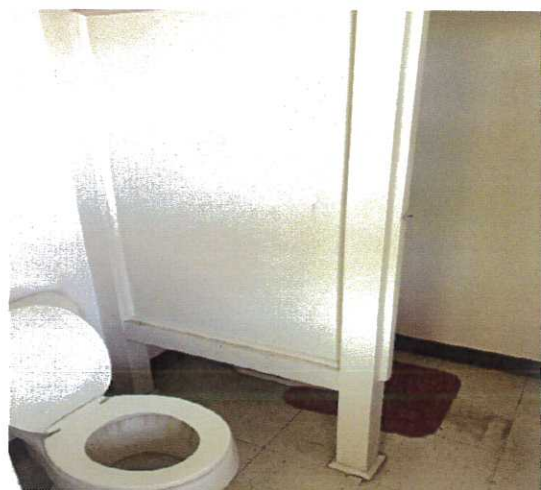
4.18 NON-COMPLIANT RESTROOM

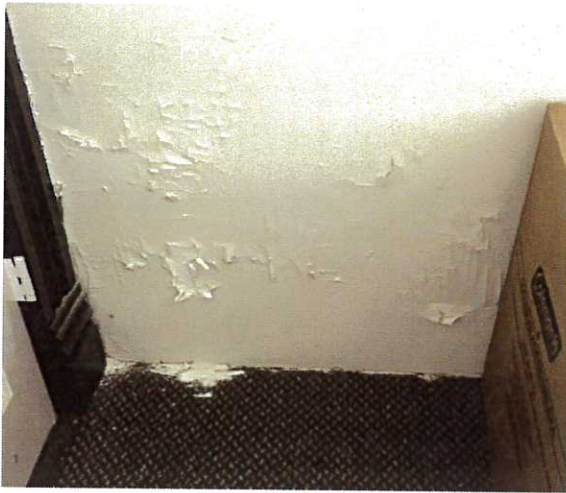
4.19 WALL DAMAGE FROM LEAKS

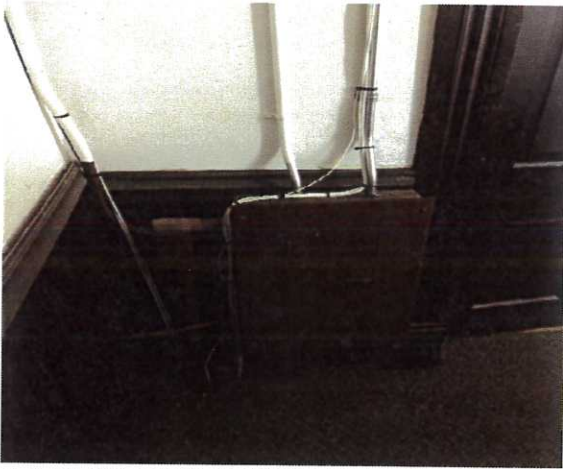
4.4.21 EXPOSED ELECTRICAL PANEL IN HALL

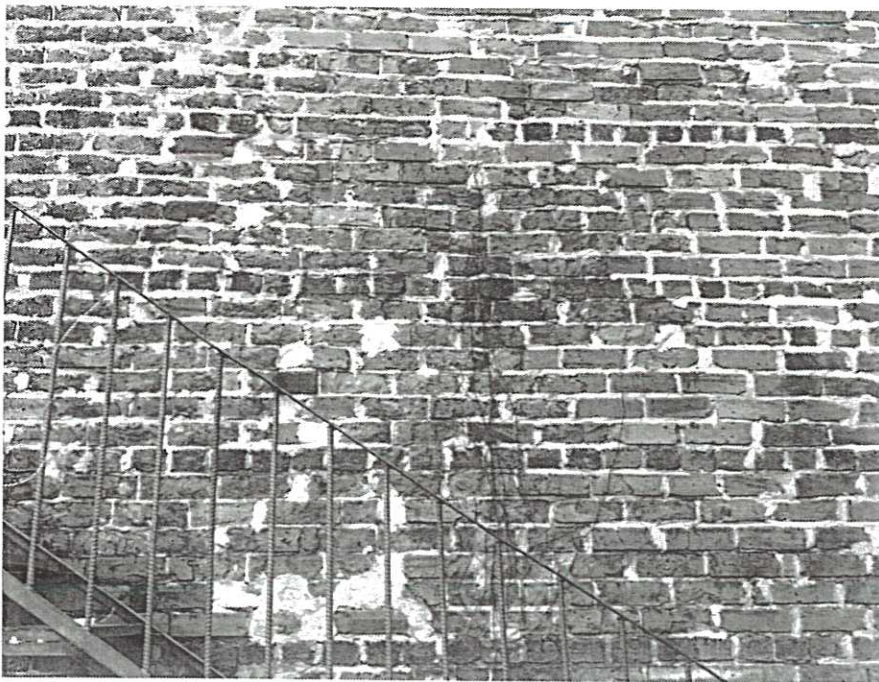
Another item of concern that will require attention prior to occupancy is the condition of the brick, particularly on the west elevation of the building. It appears that the brick has been re-pointed with Portland mortar, causing damage to the brick in a number of location; see Picture No. 8. The original brick is soft and porous by today's standards, allowing the brick to expand as it get wet. The original mortar would have been lime based in order for the mortar to be weaker than the brick, which is desired. Portland based mortar, which is commonly used in new structures today is much harder than the lime based mortar and stronger than the original brick. As the brick tries to expand, the Portland cement based mortar acts as a hard spot and does not allow the brick to expand, causing the face of the brick to pop-off. We recommend repointing the brick on the exterior of the building with a Portland and lime based mortar mix. Additionally, a brick in an arched lintel has fallen; see Picture No. 9. We recommend repairing this lintel to return it to original condition.

Picture No. 8 – Poor Condition of Brick on West Elevation

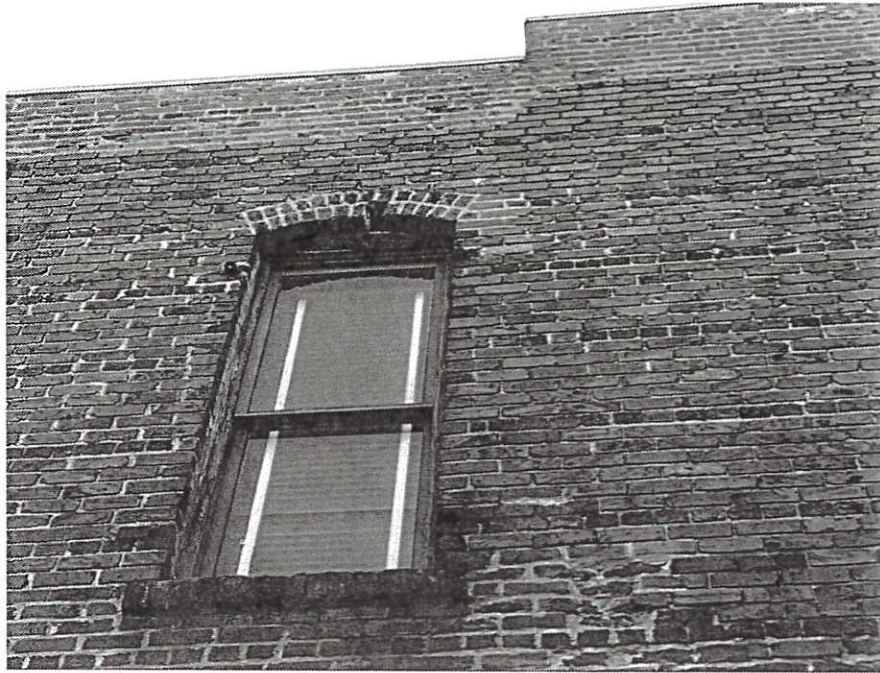
Picture No. 9 – Missing Brick in Arched Brick Lintel

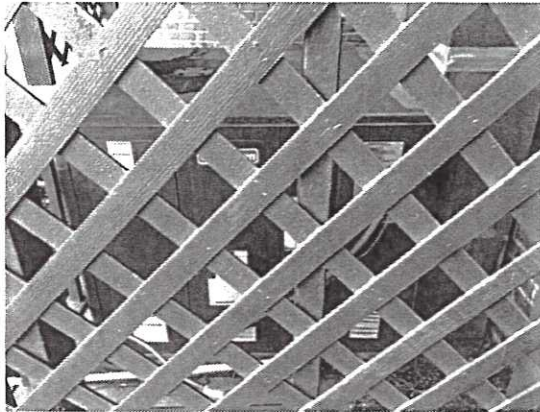
6. The packaged unit is in good condition however, the unit currently does not include an outdoor air intake hood to provide the code required fresh air.

5-ton packaged unit

9. Recommendations:
 - a. Install an outdoor air hood and motorized outdoor air damper on existing packaged unit such that the unit can provide the code required minimum outdoor air to the first floor.

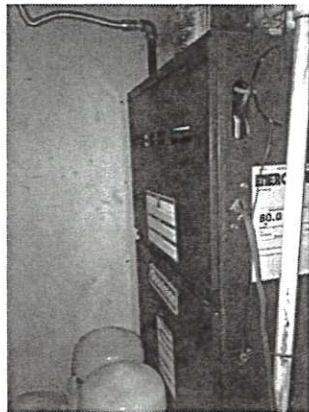
6. The Men's and Women's restroom do not have adequate exhaust.
7. Currently, there is an IT Closet on the second floor without cooling capability.
8. The split-system is in good condition, however, the unit currently is not provided with outdoor air and therefore does not meet current ventilation requirements.

5-ton split-system gas furnace

11. Recommendations:
 - a. Install outdoor air duct from new intake hood or louver to the return air plenum to provide the code required minimum outdoor air to the second floor.

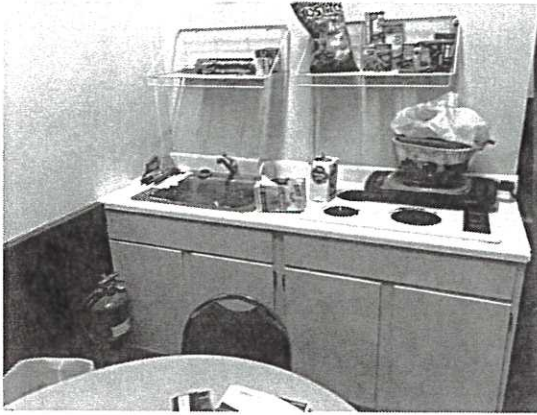
1. There is a break room on the north side of the building. There is a single compartment sink that is in poor condition.
2. The first floor restroom includes a tank-type water closet (toilet) and wall mounted lavatory. Neither the water closet nor the lavatory meet ADA requirements.
3. A washing machine box is installed in the break room area. The box is no longer used. It is recommended that the box be removed and the water and sanitary sewer piping be removed back to the main piping from which they are fed from and capped.
4. Recommendations:
 - a. Replace break room sink and faucet.

Break room sink

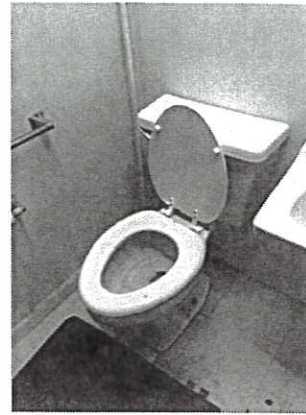
Tank-type water closet

- b. Replace restroom water closet and lavatory. Modify existing plumbing water and sanitary sewer to make restroom ADA compliant.

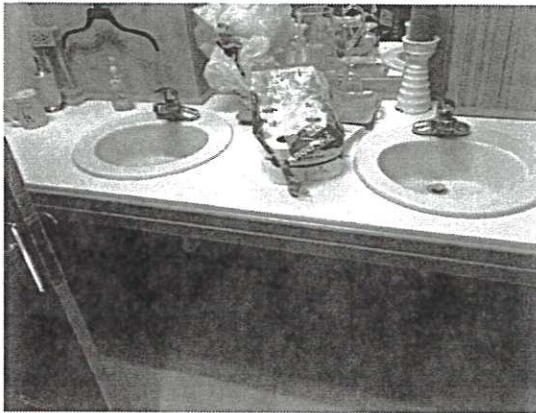
1. Installed in the women's restroom are two (2) counter mounted lavatories. The lavatories do not meet ADA requirements. Also in the women's restroom are two (2) tank-type water closets. The water closets do not meet ADA requirements.
2. Installed in the men's restroom are two (2) integral counter mounted lavatories. The lavatories do not meet ADA requirements. Two (2) showers are installed in the men's restroom along with two (2) tank-type water closets. Neither the showers nor the water closets meet ADA requirements.
3. Domestic hot water is provided by a 50 gallon natural gas water heater. The water heater appears to be in fair condition.
4. The domestic hot and cold water appears to be uninsulated.
5. Recommendations:

Women's room lavatories

- a. Replace all lavatories and faucets. Provide a minimum of one lavatory that is ADA compliant.
- b. Replace all water closets. Provide a minimum of one water closet that is ADA compliant.
- c. Remove showers.
- d. Modify existing plumbing water supply and sanitary sewer piping as required to install new plumbing fixtures.
- e. Replace existing 50 gallon water heater.
