PRELIMINARY OPINION OF PROBABLE COST

WEST MADISON UTILITY DISTRICT

SANITARY SEWER LAGOON RELOCATION AND ASSOCIATED WORK

**Mississippi Department of Environmental Quality
Office of Pollution Control
Water Compliance Inspection Report**

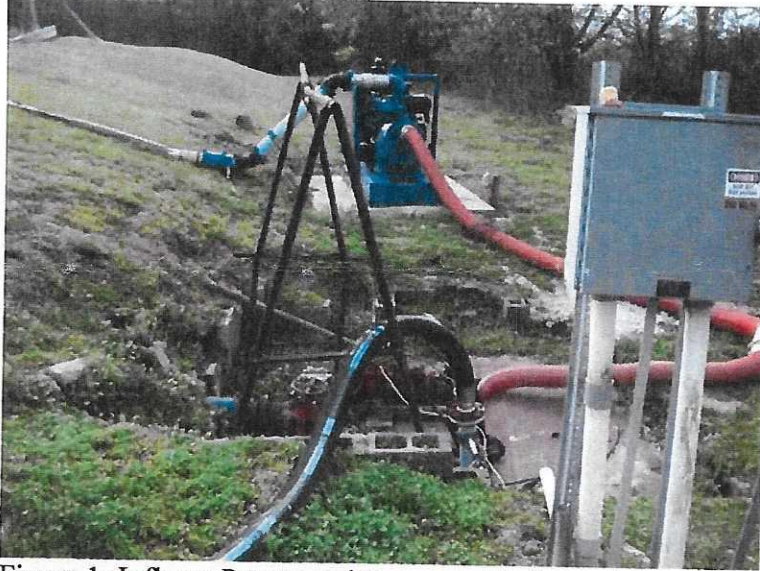
Figure 1: Influent Pumps and Permanent Influent Bypass

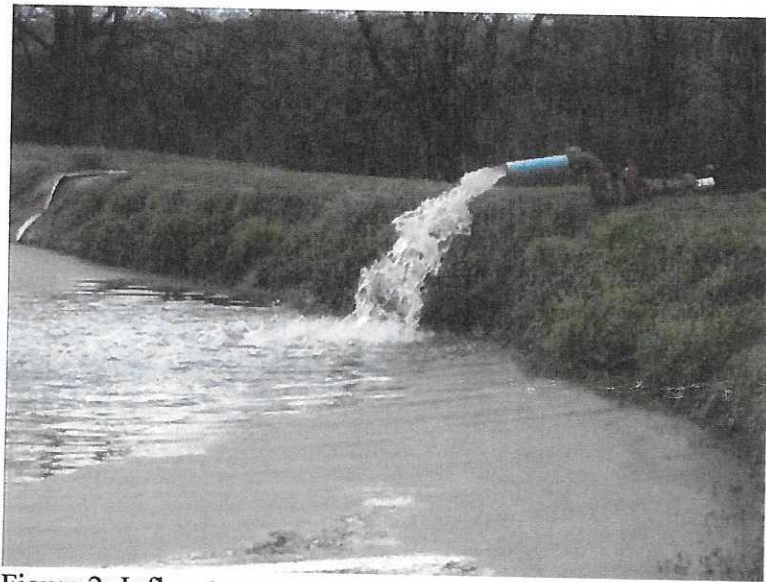
Figure 2: Influent

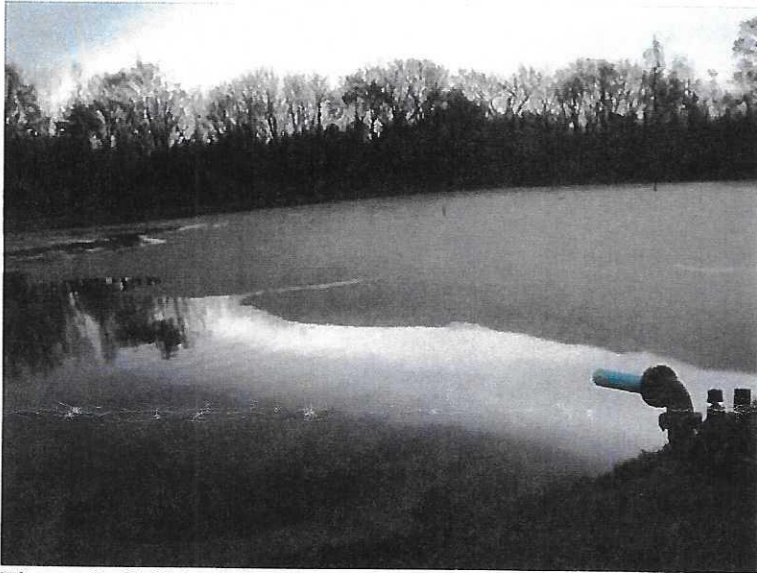
Figure 3: Cell 1 of the Lagoon (Settling Pond)

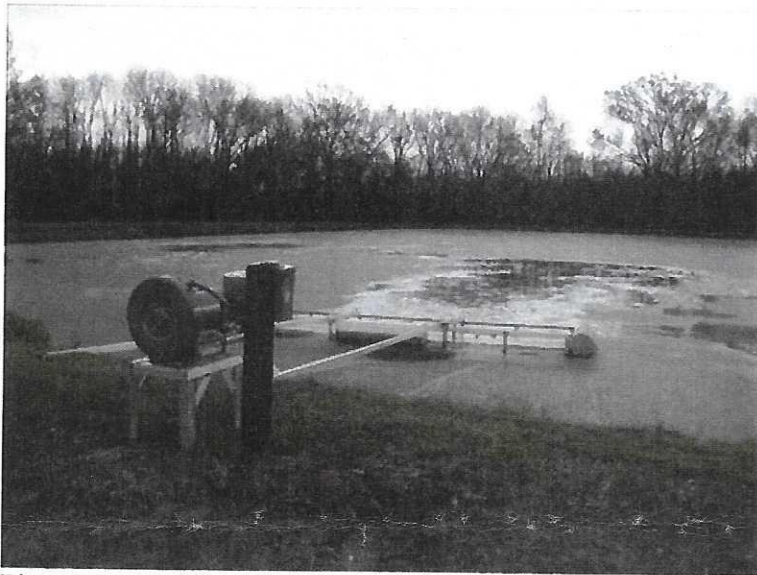
Figure 4: Diffused Aeration

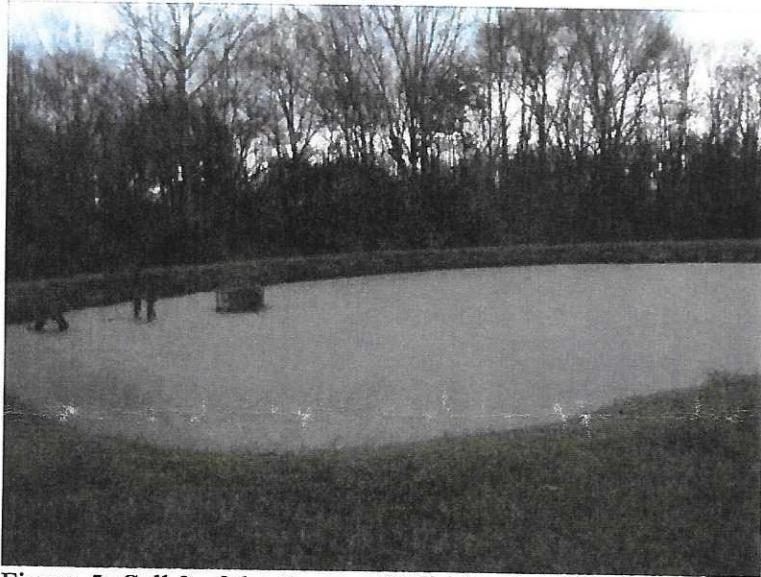
Figure 5: Cell 2 of the Lagoon (Polishing Pond)

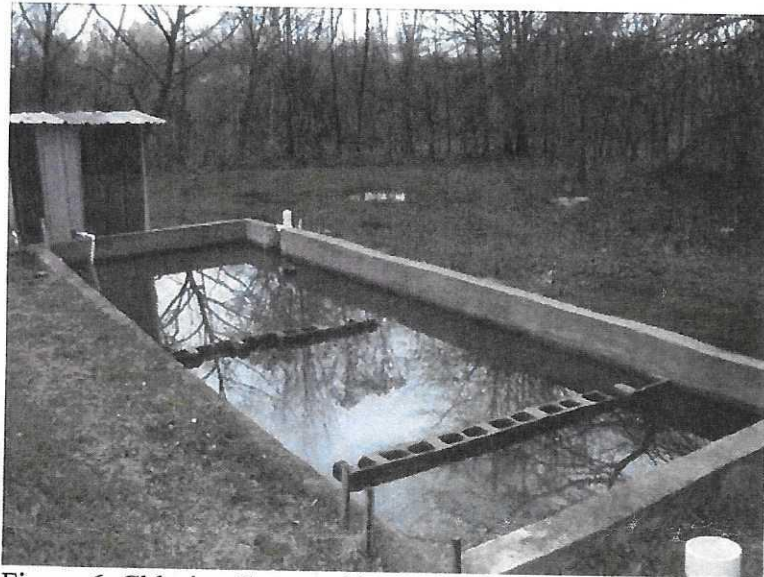
Figure 6: Chlorine Contact Chamber

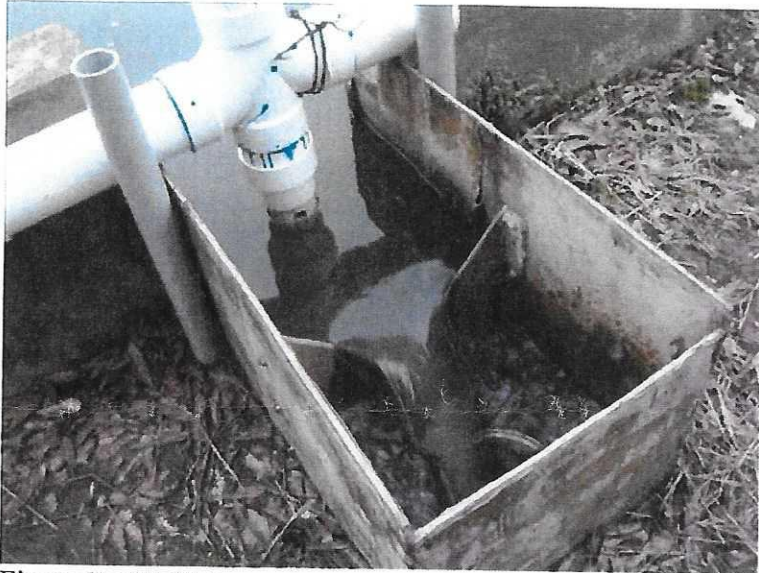
Figure 7: 90° Weir

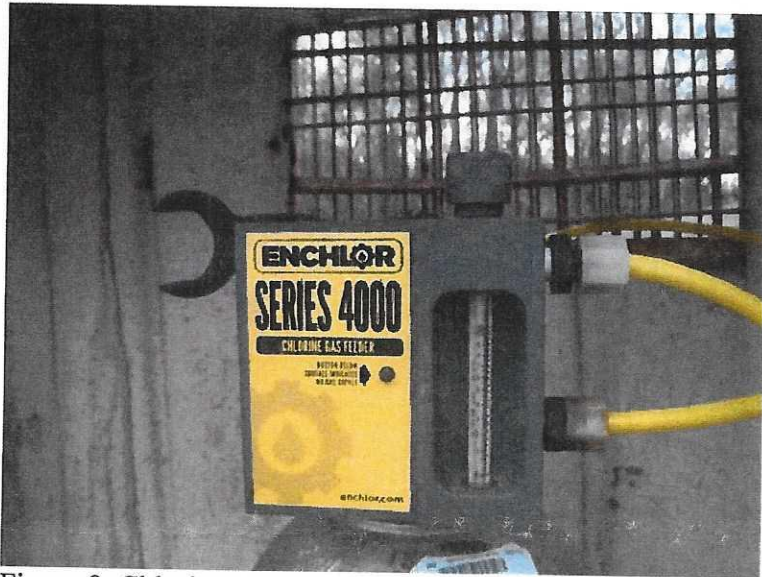
Figure 8: Chlorinator

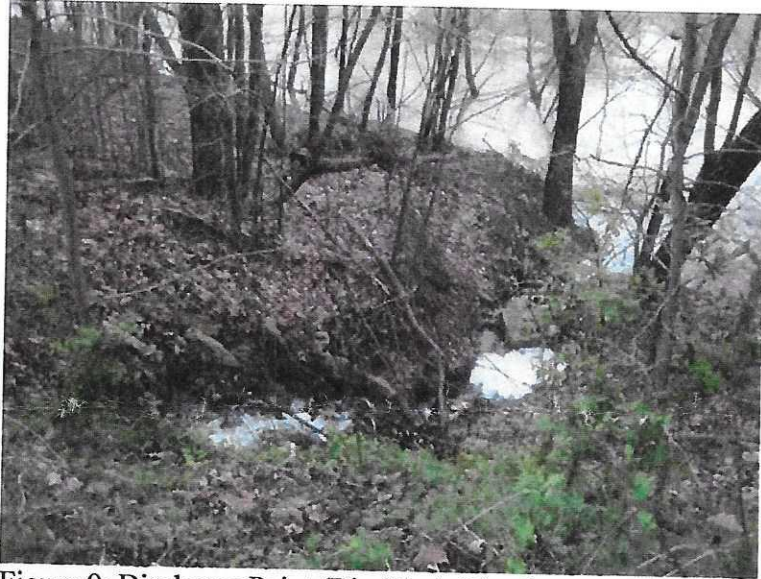
Figure 9: Discharge Point (Big Black River)

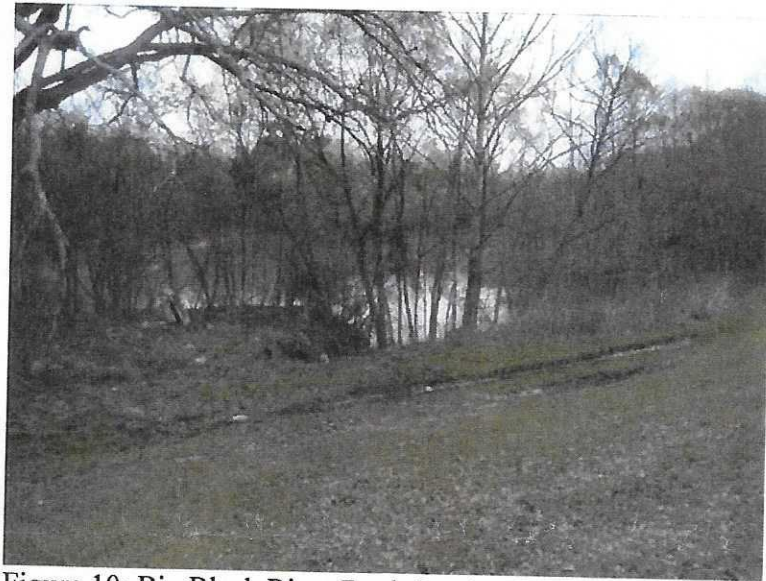
The facility is located alongside the Big Black River at a bend in the river, and each year the river continues to erode the toe of the bank. This causes the bank to erode closer to the facility. The continued erosion eventually will reach the facility causing a catastrophic failure of the treatment system and the potential of a significant impact to the environment and human health if untreated wastewater is discharged into the Big Black River.

Figure 10: Big Black River Bank Erosion at the Facility

1. Plans for an alternative treatment system/location or sending the wastewater to another facility for treatment should be considered and a plan established due to the continuous erosion problem of the Big Black River banks encroaching on the facility. These measures must be considered and implemented to avoid catastrophic failure of the treatment system and the potential of a significant impact to the environment and human health if pollutants are discharged.

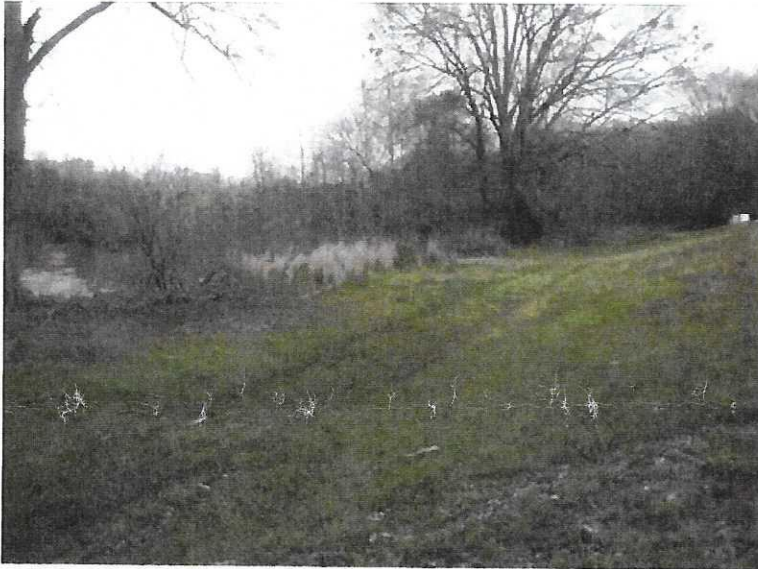
Figure 10: Distance of the Bank Erosion from the Facility's Levee.

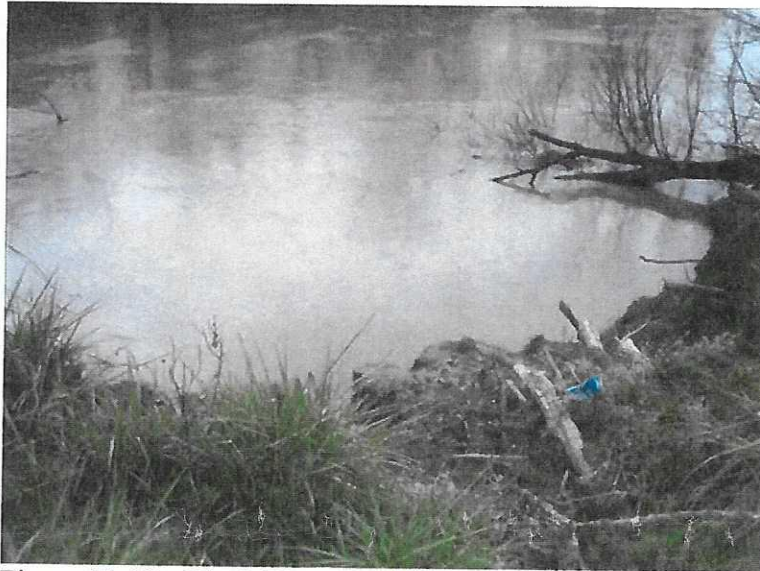
Figure 11: Big Black River Bank Erosion at the Facility

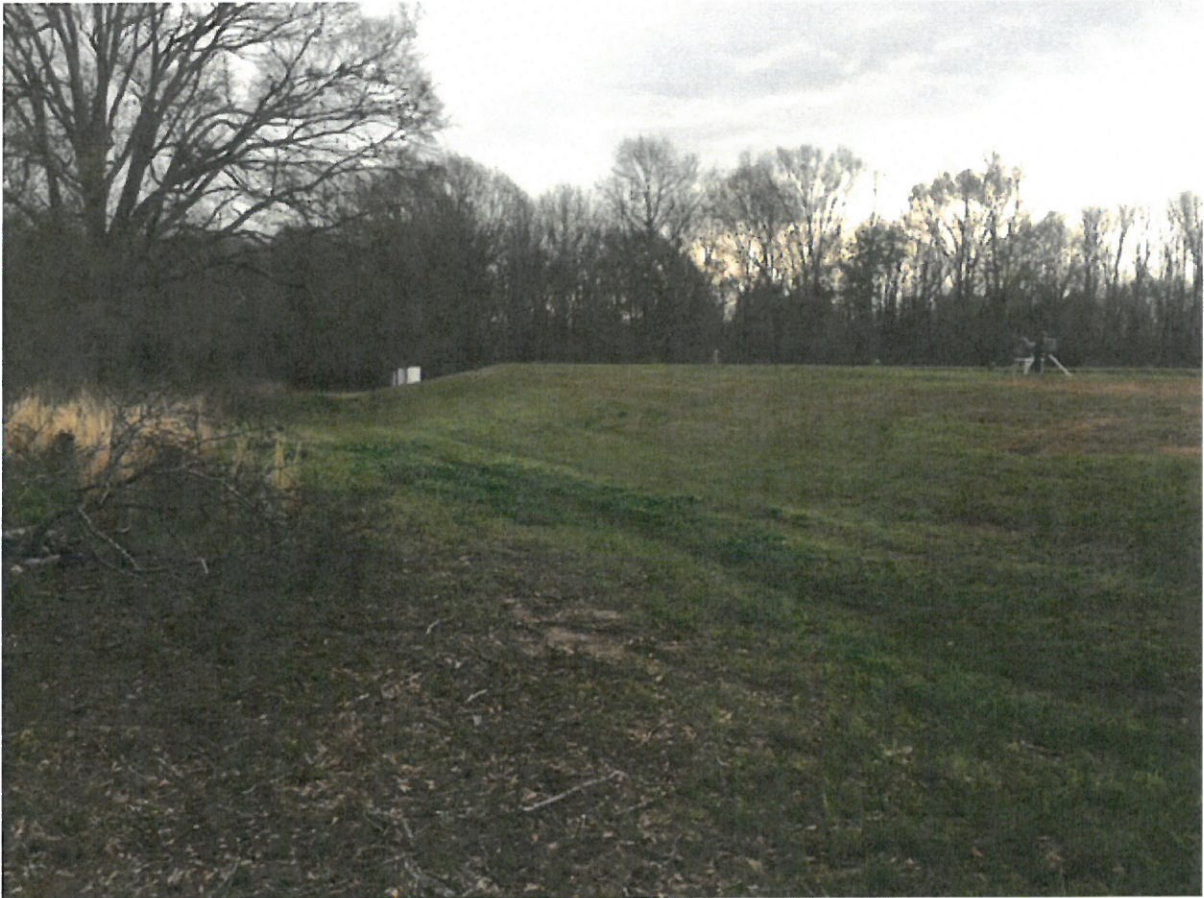
We recently conducted a site visit to the wastewater lagoon, located on the banks of the Big Black River. While we were there to gather data on the influent pump station and other components of the treatment process, we observed a condition with the river bank that we believe needs immediate attention. The river bank has sloughed severely and at one point is only 25 feet from the toe of the lagoon levee. It is our opinion that the lagoon is danger of being lost in a few more "sloughing" events.

Photo taken in March 2017 shows how close the river bank soughing is to the toe of the lagoon levee.

We would like to request a site visit by your agency and begin formulating a solution to the problem.

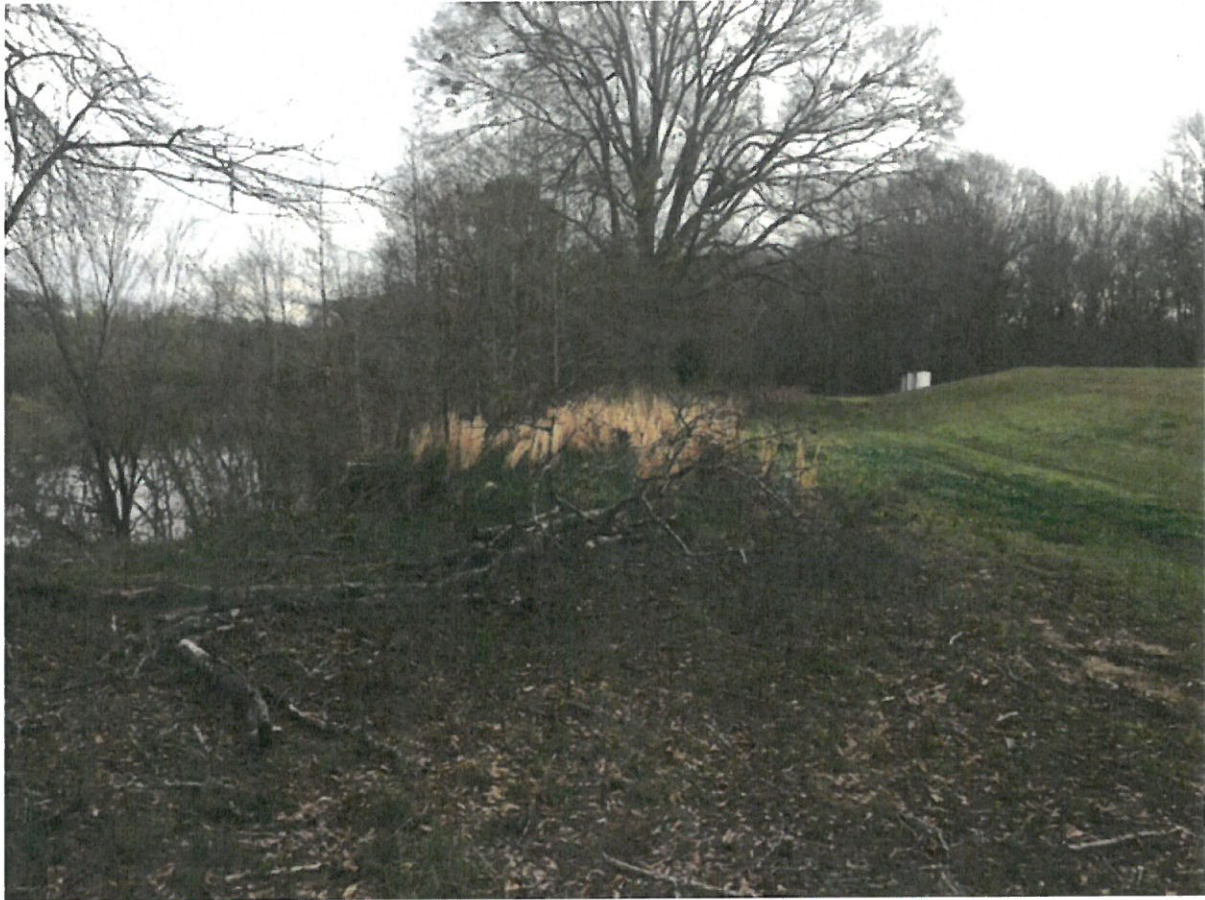
Photo taken in March 2017 shows how close the river bank soughing is to the toe of the lagoon levee.

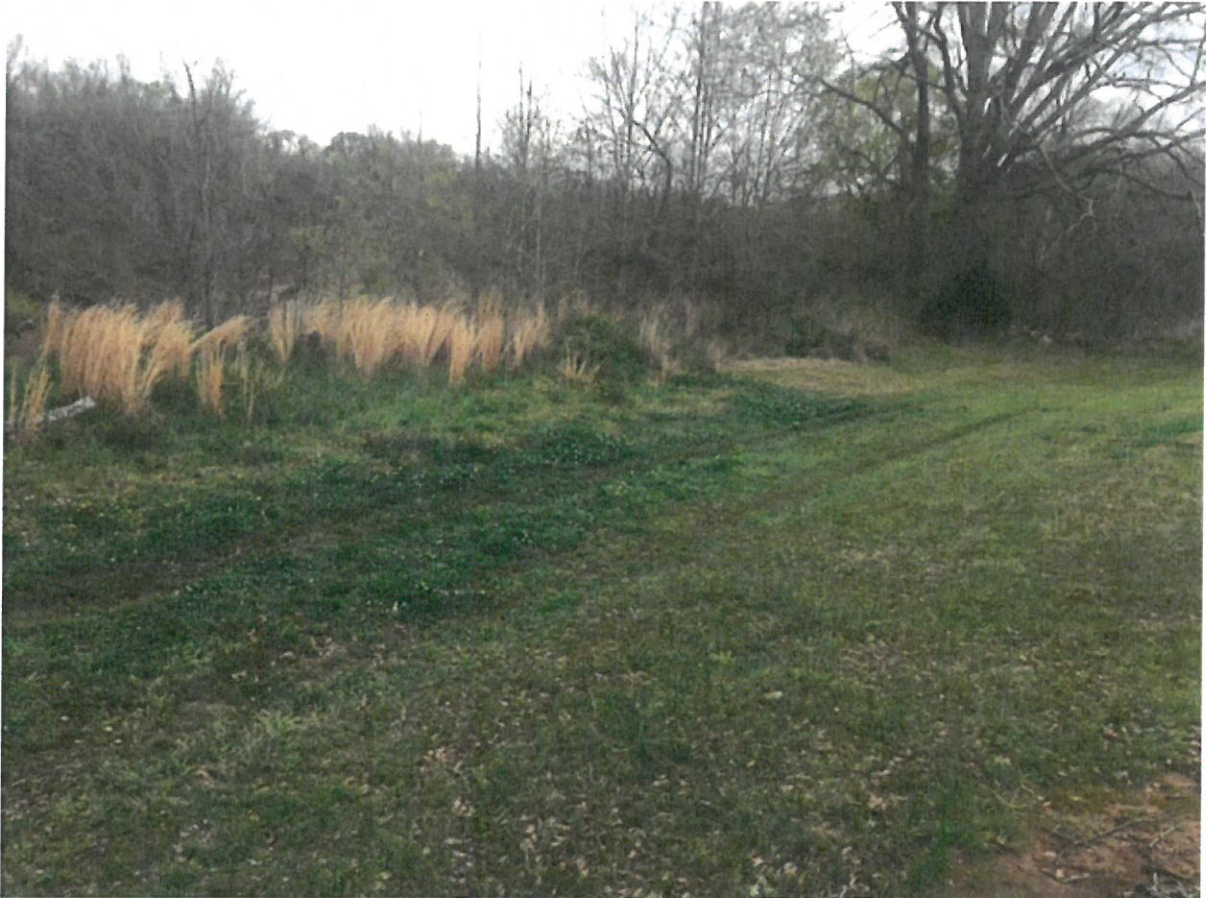
Photo taken in March 2017 shows how close the river bank soughing is to the toe of the lagoon levee.
