Petition

Madison County, Mississippi

The below property owners of Blackberry Creek Subdivision wish to petition the Madison County Board of Supervisors to assist with flooding of the roadway, ditching, erosion and asphalt surface maintenance of Blackberry Creek Road, thus limiting Madison County's liability exposure.

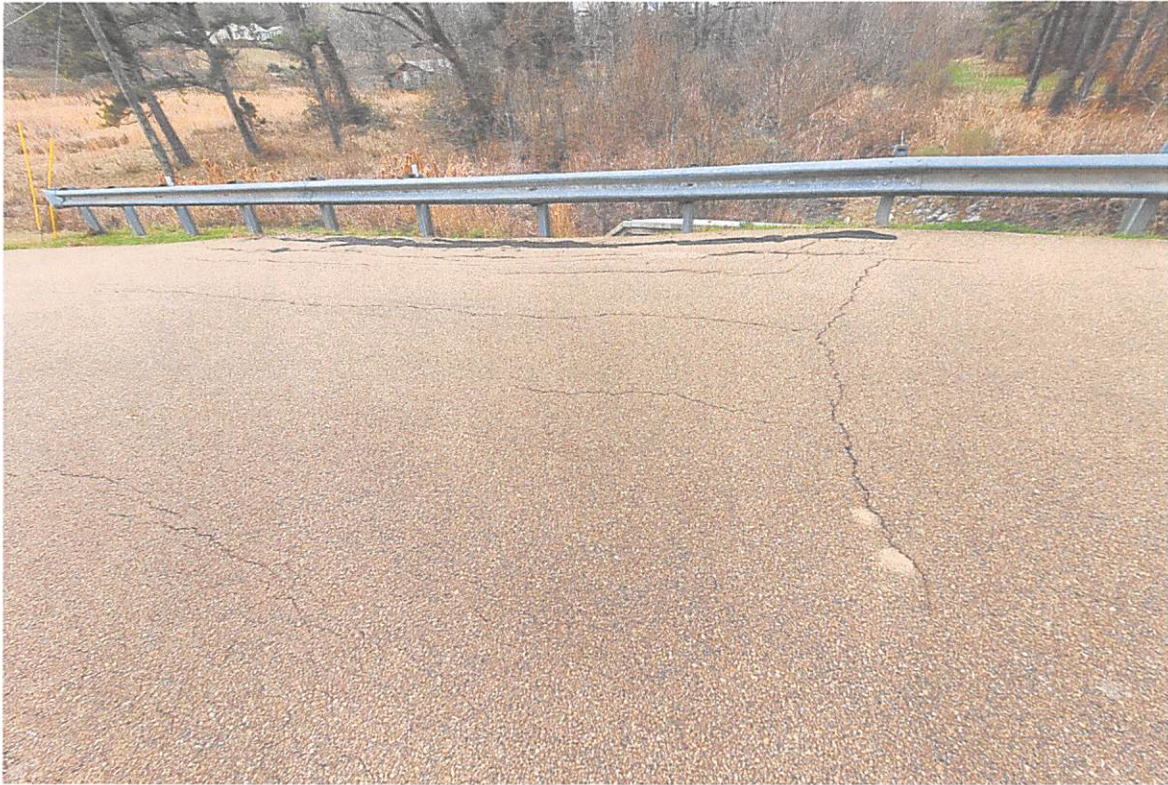
Picture 1/14

The cracks and depression of the asphalt surface indicates erosion of the covering of the arched culvert of the creek. There is a required depth of covering . If less cover is present the arch is subject to deformation and failure.

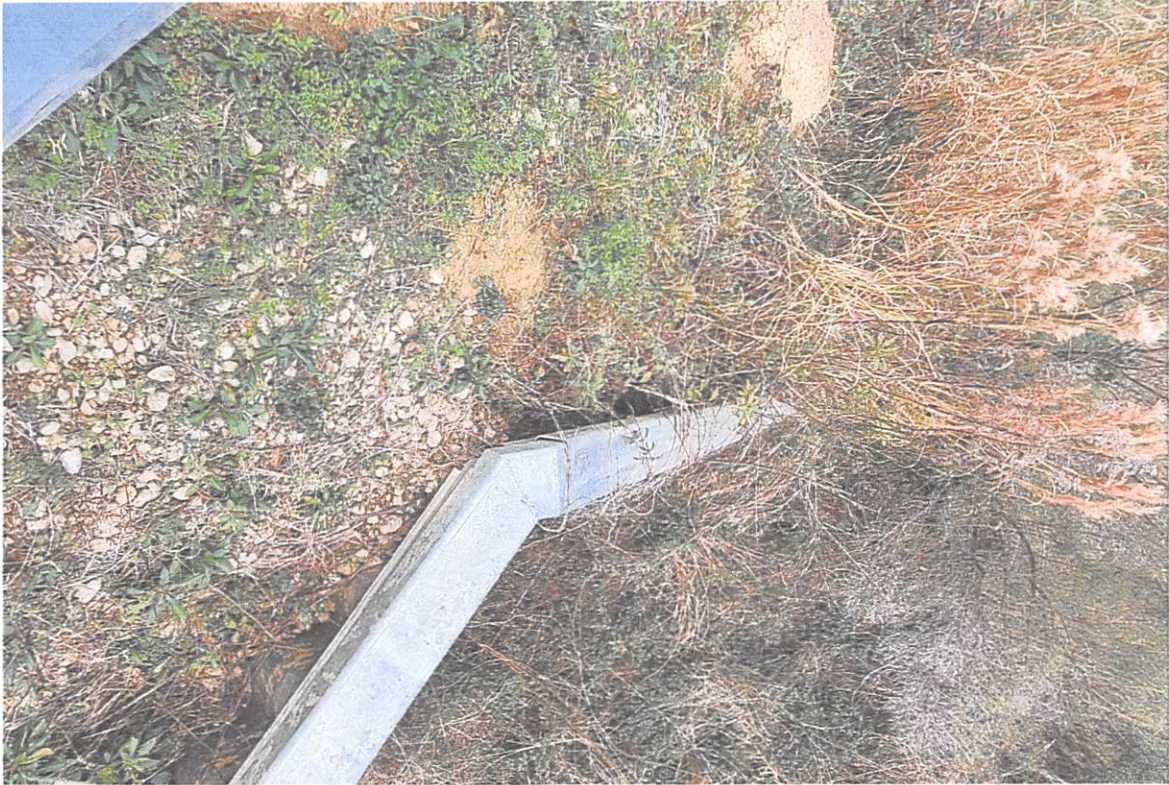
Picture 2/14

This picture at the wing wall of the arched culvert shows continued erosion of the roadway base.

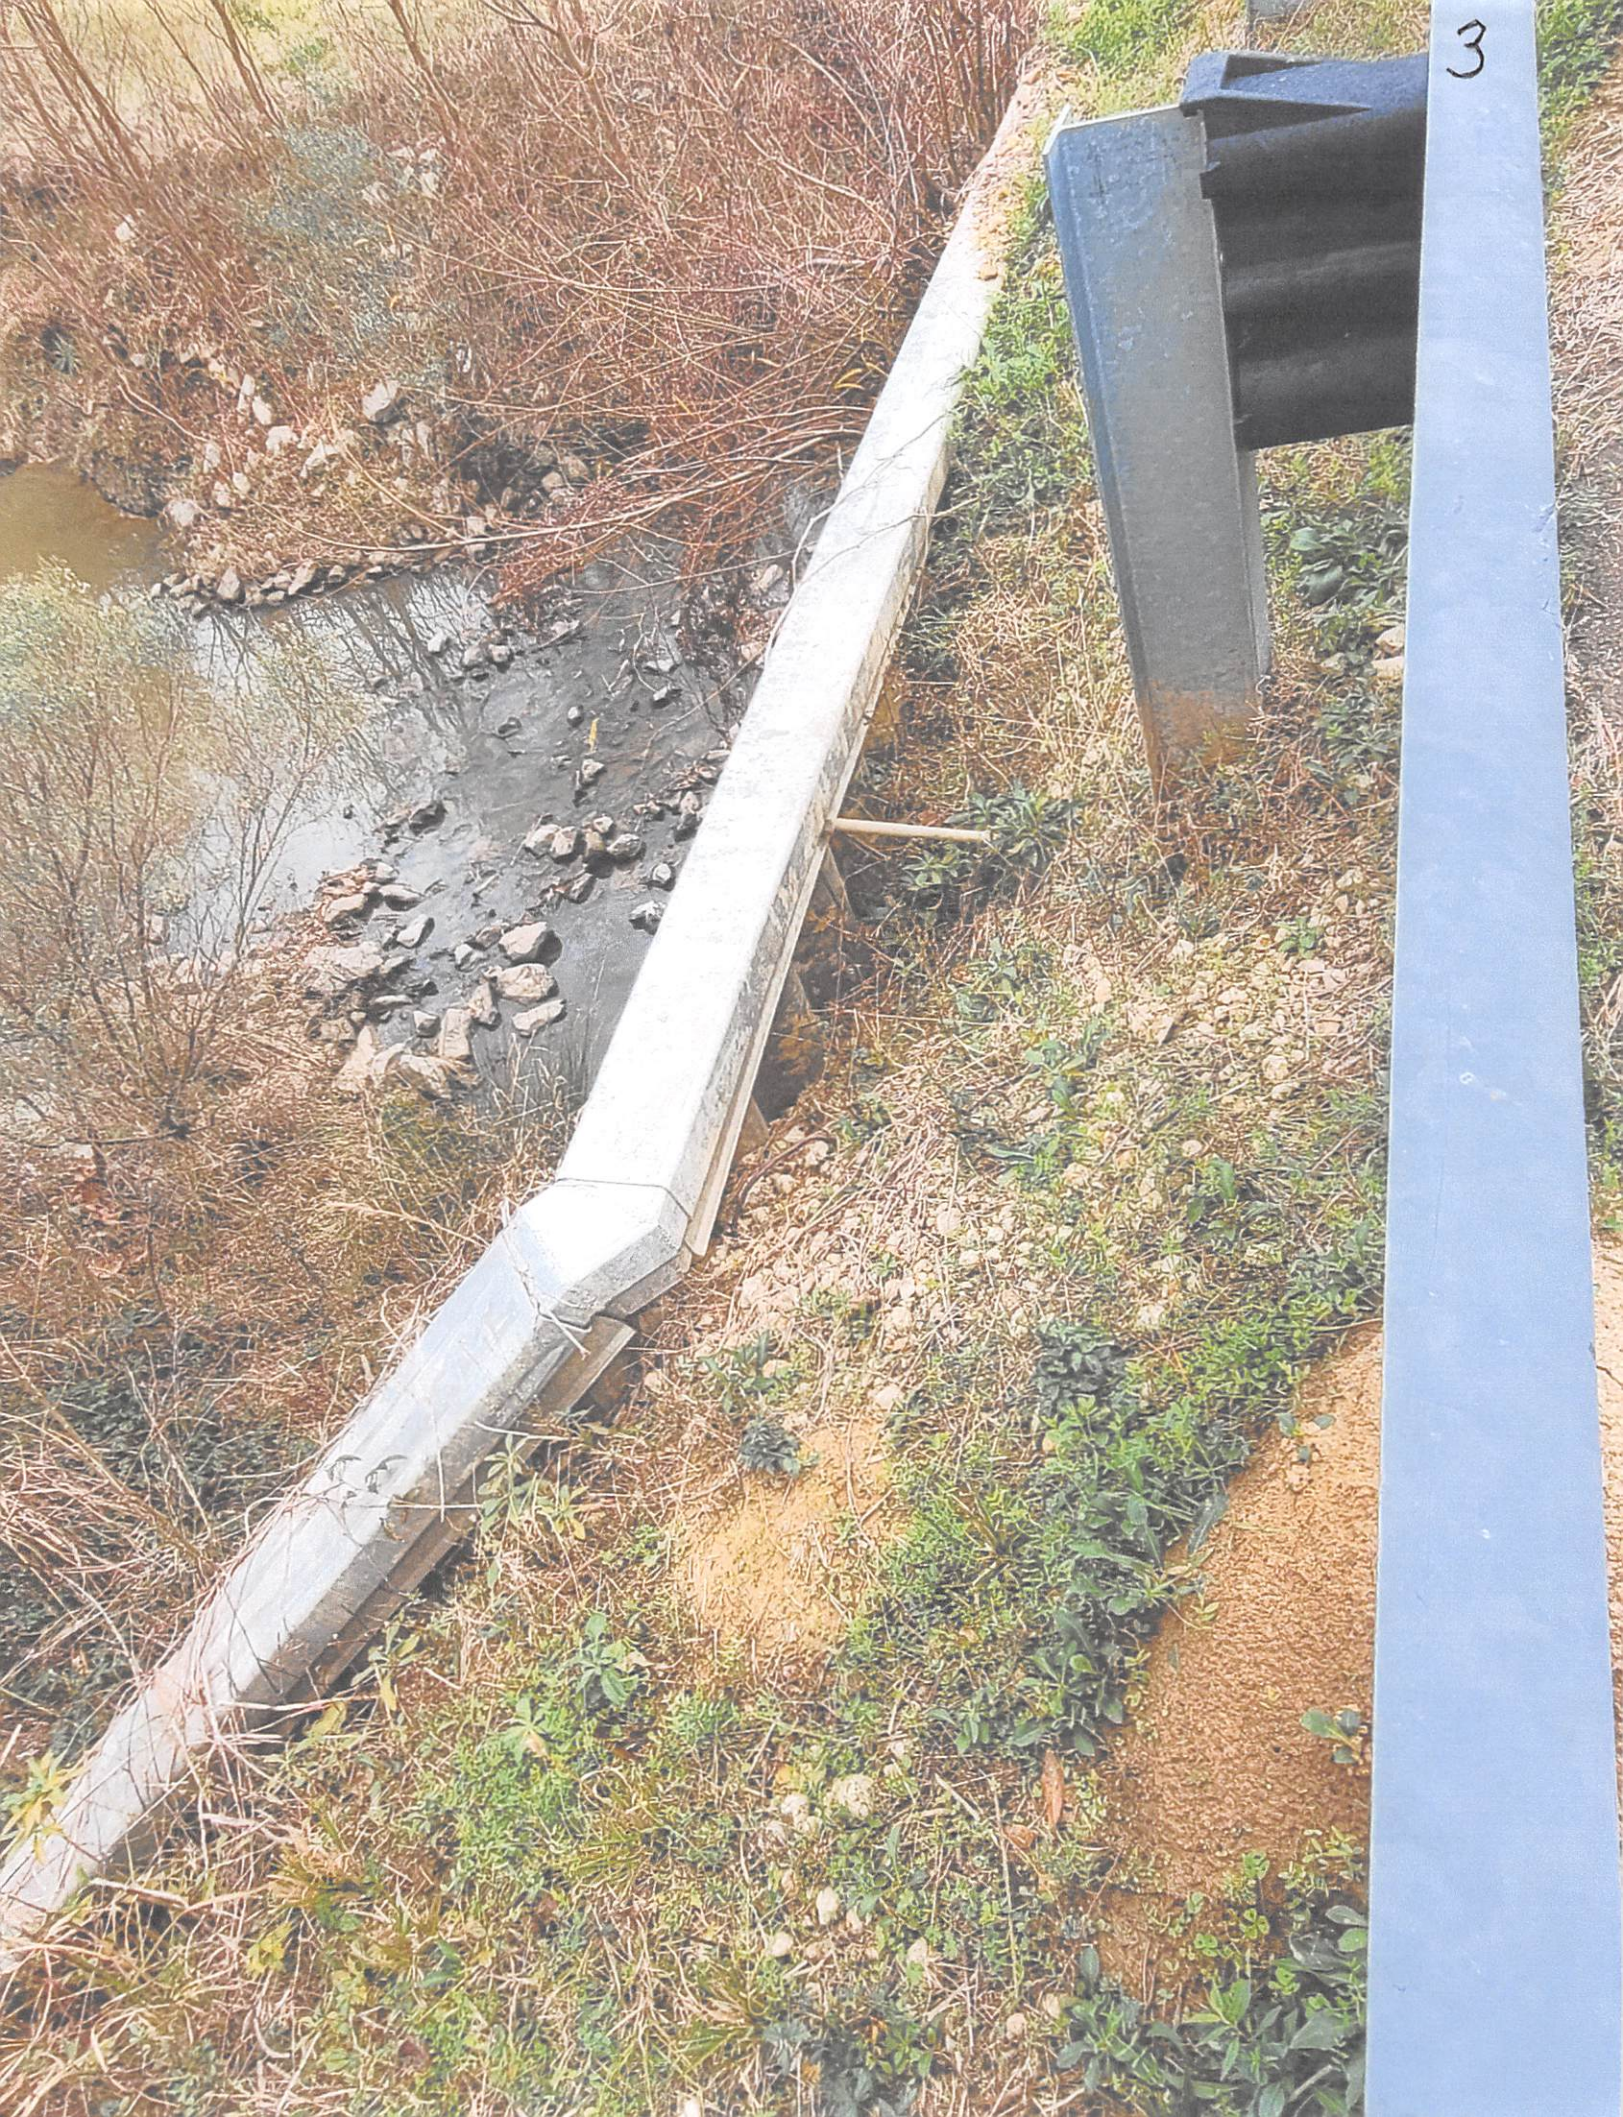
3

The picture of the following page shows continued erosion of the roadway base on the other side of the arched culvert.

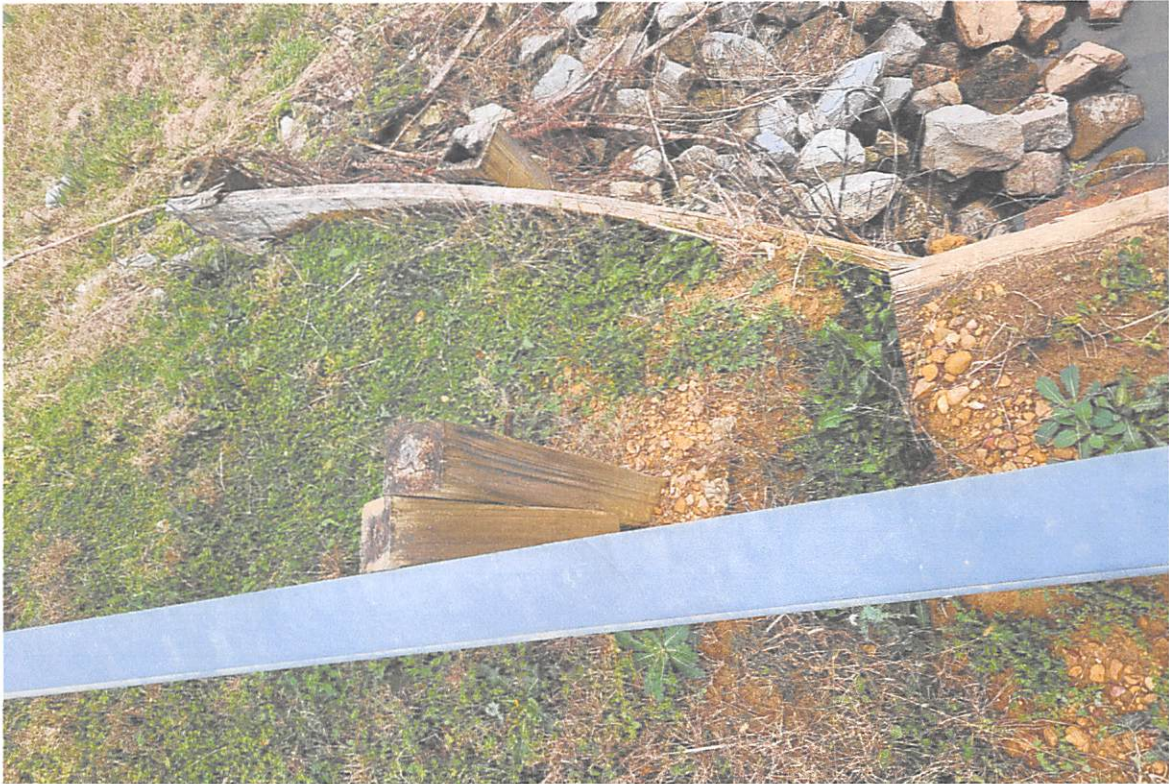
Picture 4/14

This picture shows erosion of the roadway base at the box culvert of the roadway.

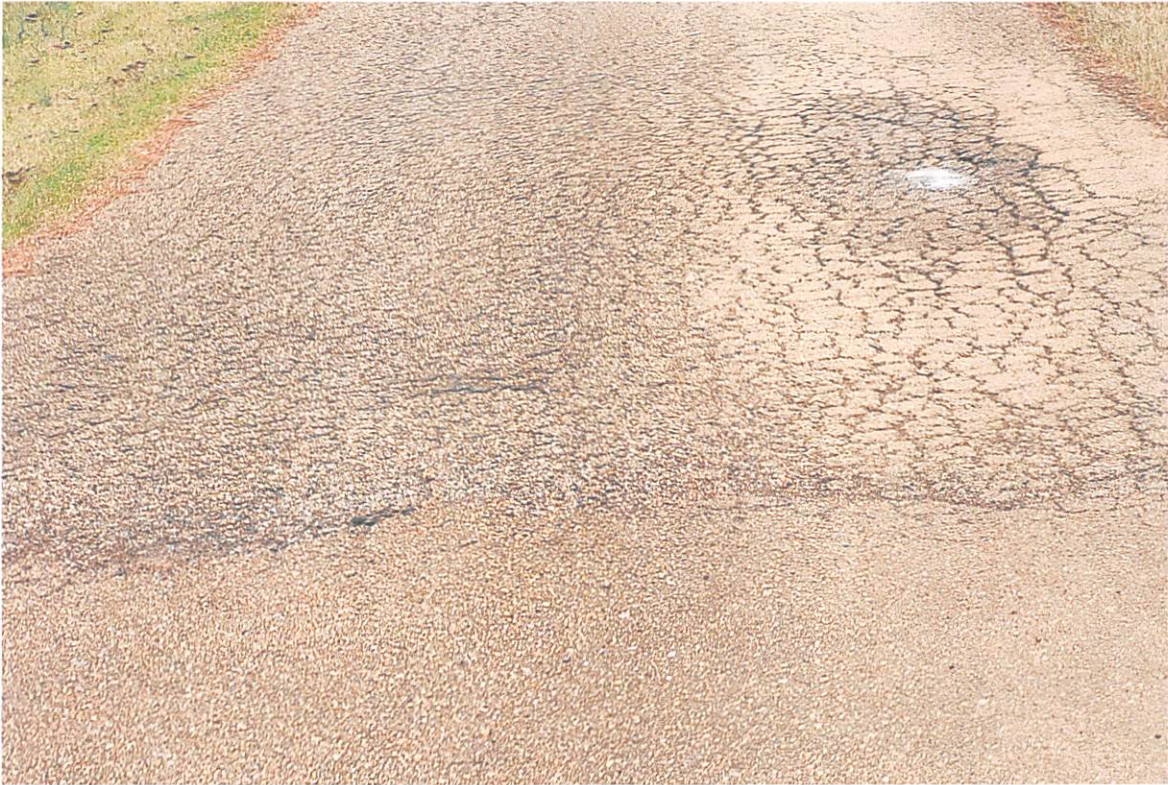
Picture 5/14

This picture shows alligatoring and the formation of a large pothole in the roadway surfacing. This, as you know, indicates complete failure of the roadway surfacing.

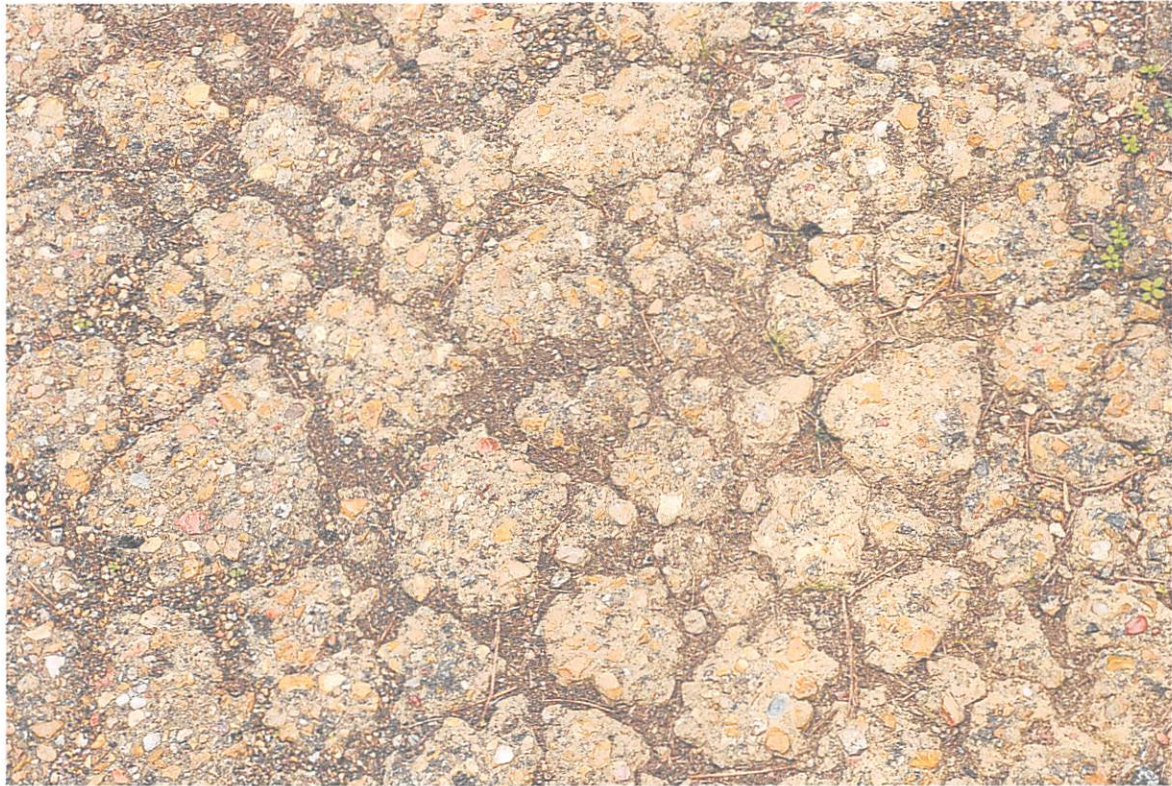
Picture 6/ 14

This picture shows complete failure of the roadway surfacing.

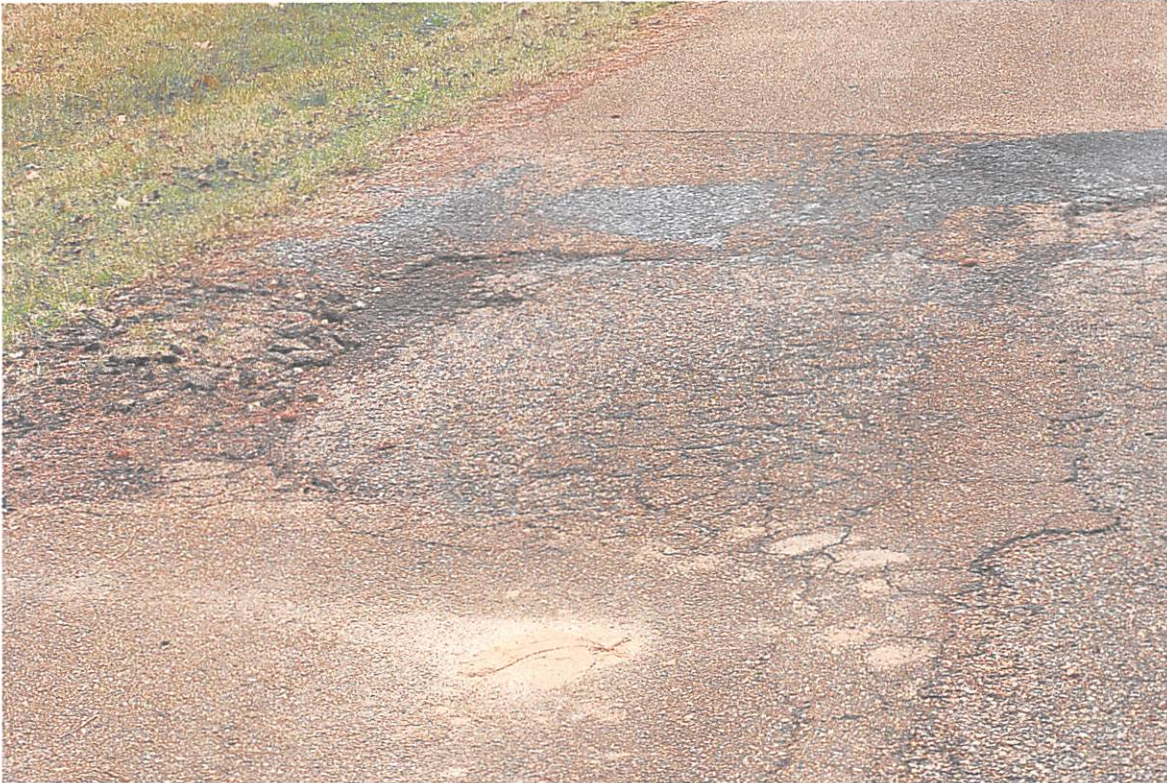
Picture 7/14

This picture shows complete failure of the roadway surfacing.

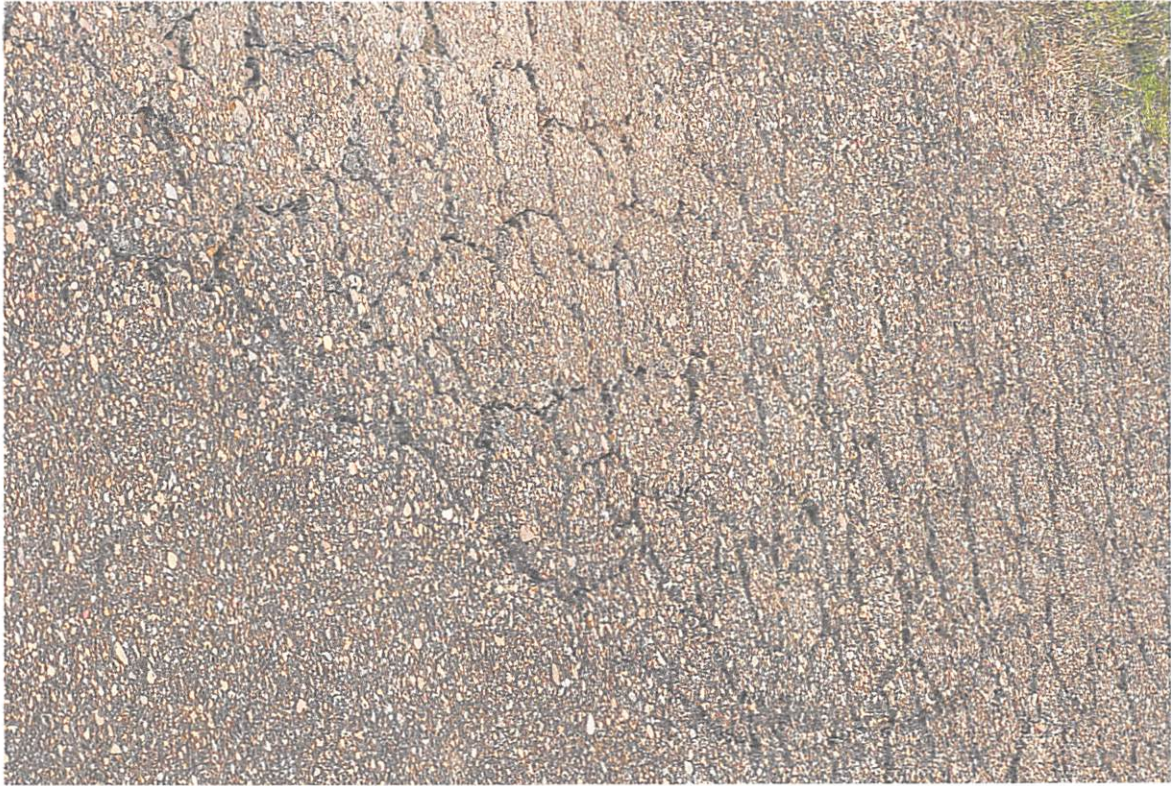
Picture 8/14

This picture shows widespread alligatoring.

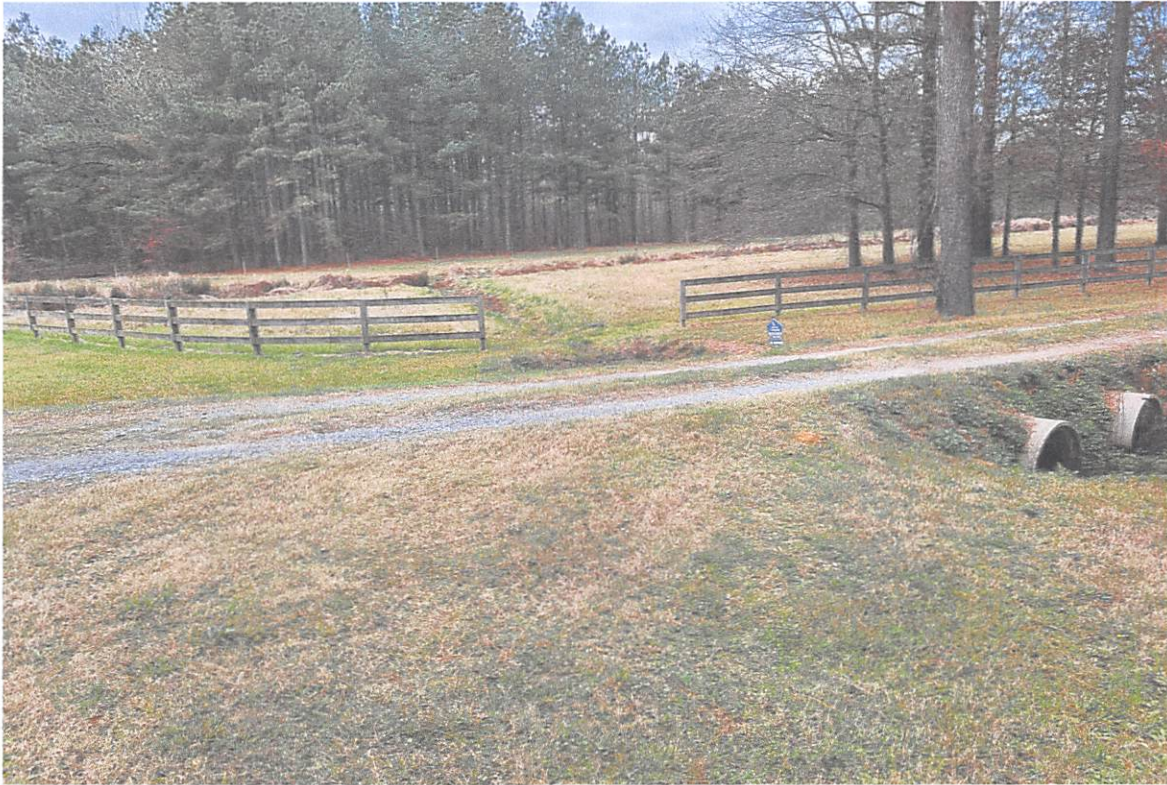
Picture 9/14

His picture shows the lack of proper roadway ditching that allows rainwater to flow freely across adjacent property causing erosion, ditching and prevents the use of the adjacent property.

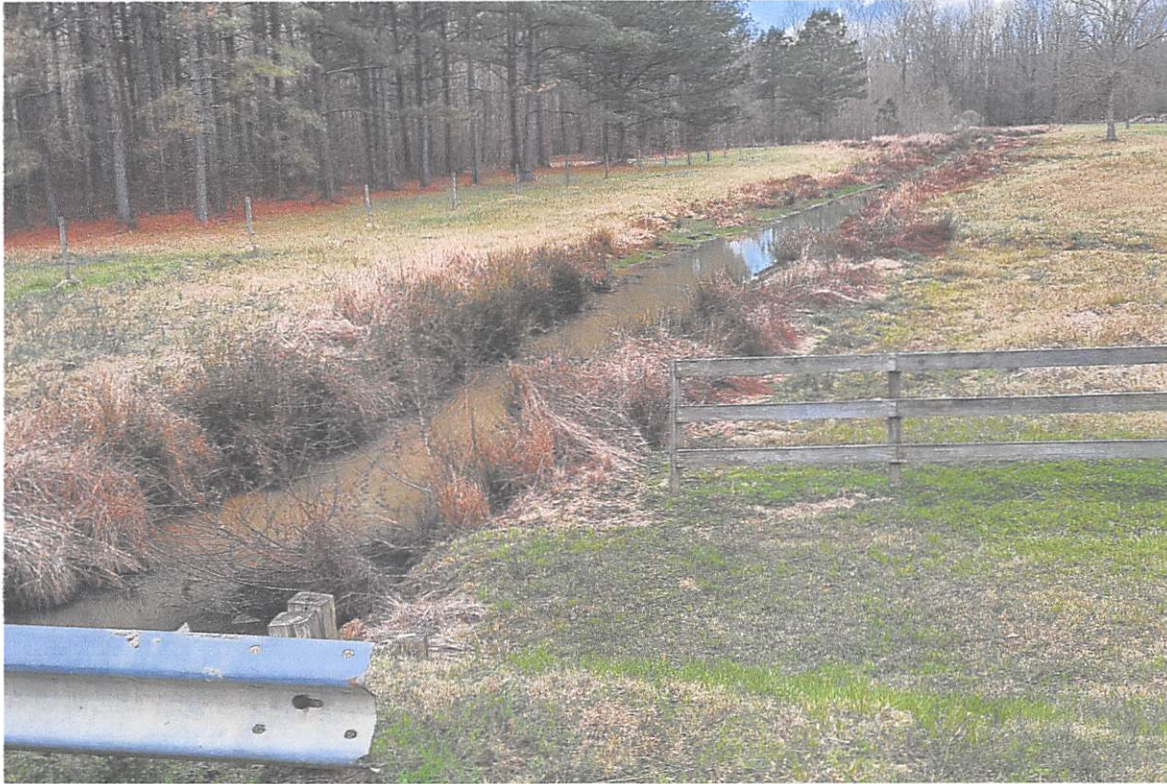
Picture 10/14

This picture shows the erosion has formed a ditch east of the roadway at the box culvert. This eroded ditch that was caused by the rain water being "funneled" through the box culvert and not collected by a ditch that would take the water to the existing ditch south of the box culvert causing this property not to be usable.

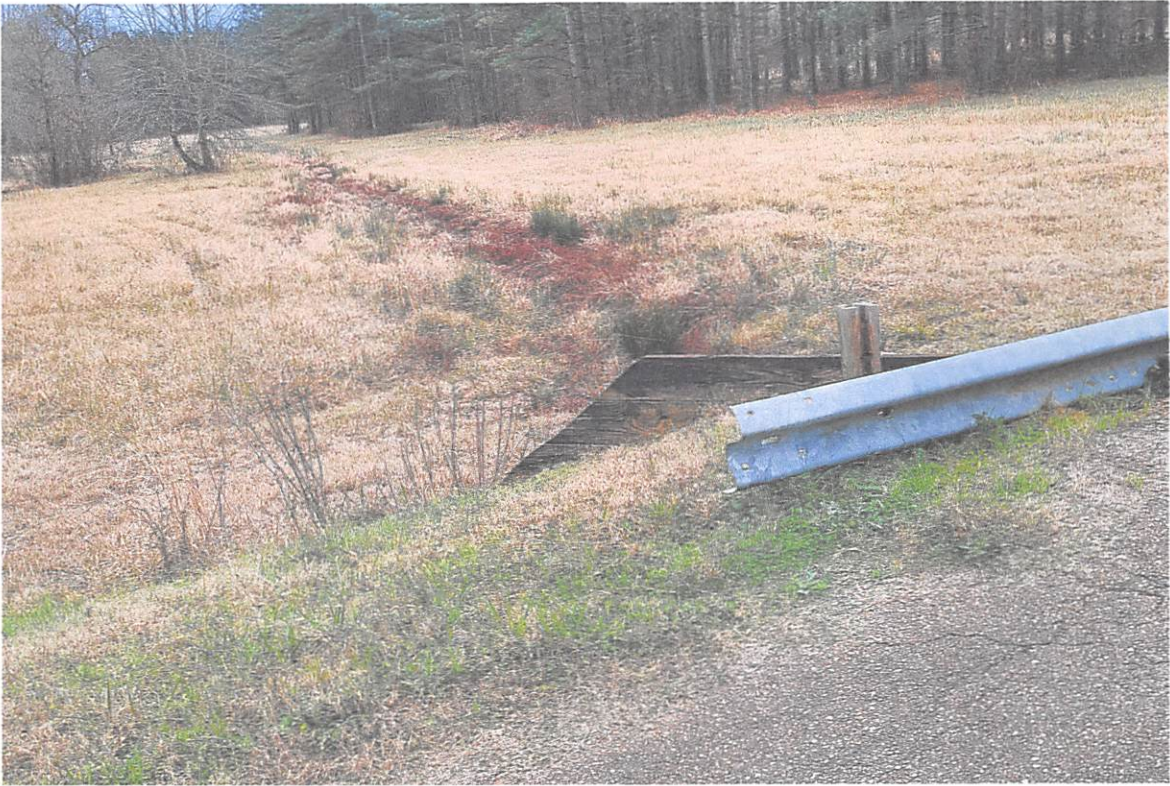
Picture 11/14

This picture shows the eroded ditch west of the roadway at the box culvert that seems to be caused by water flowing from a pipe under the roadway west of the 90 degree westward turn in the roadway (as shown on picture 14). There is no ditch collecting the water at the effluent of the pipe that would take the water along the roadway instead of across the property.

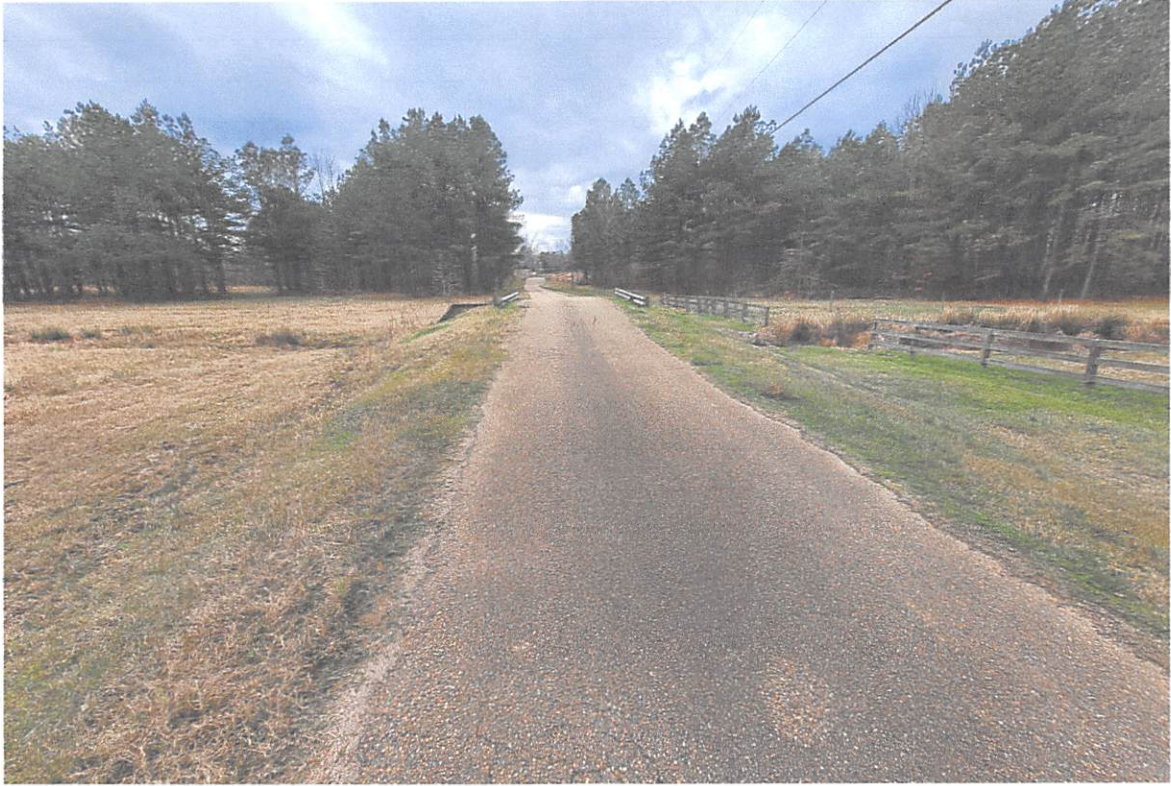
Picture 12/14

This is a picture of the roadway approaching the box culvert. This picture shows the lack of roadway ditches.

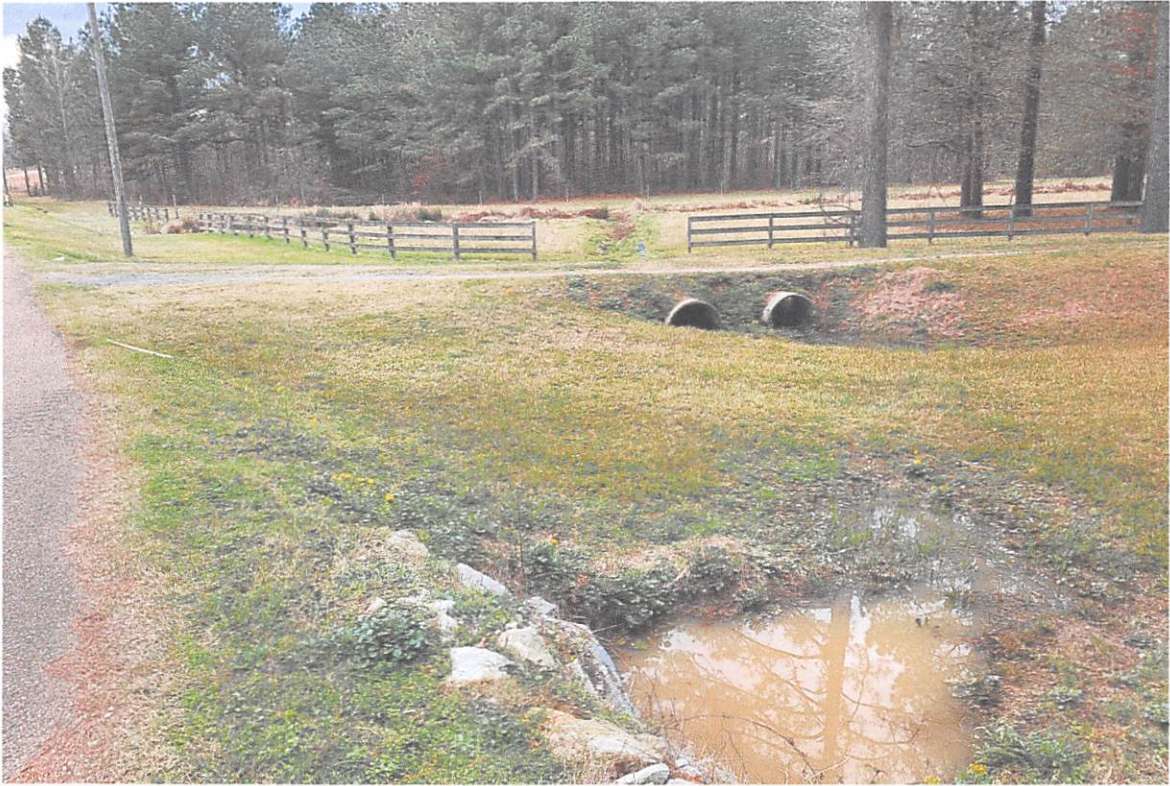
Picture 13/14

This is a picture of the roadway near the 90 degree turn on the east side. This picture shows the lack of proper ditching of the roadway.

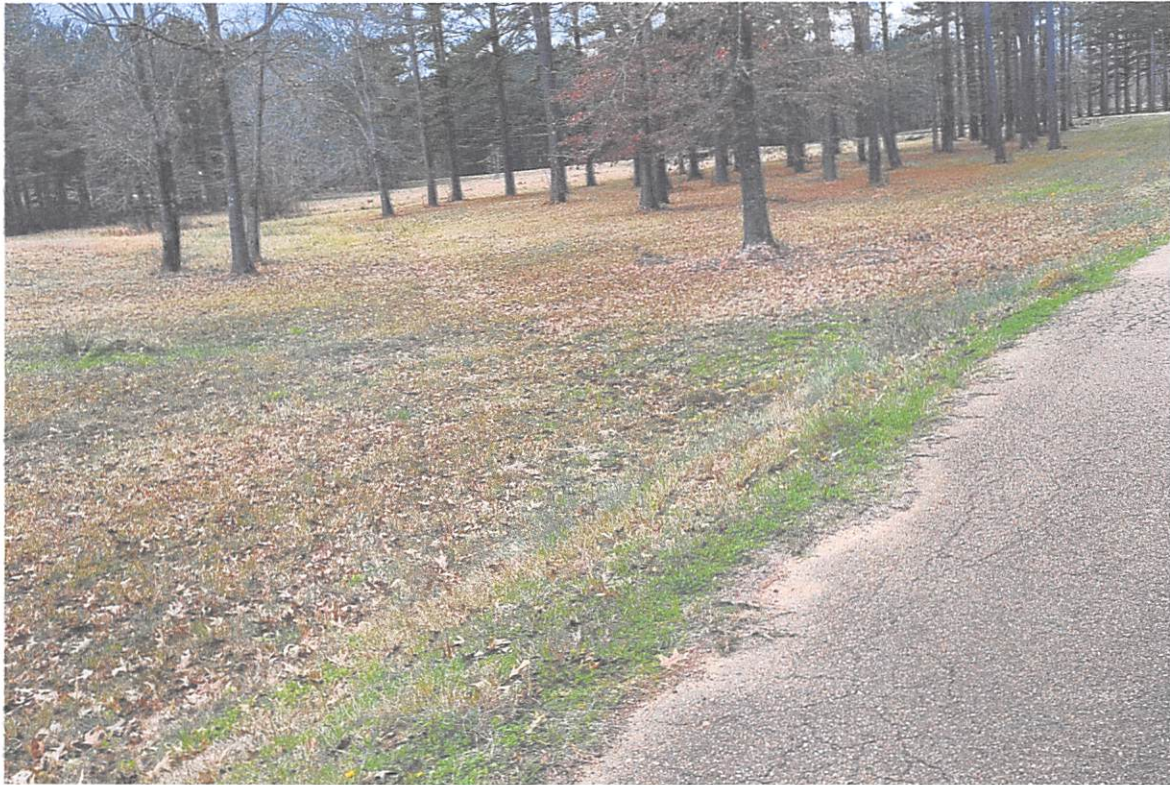
Picture 14/14

This picture shows the outflow of the pipe that is allowed to flow across the adjacent property. In the distance is the eroded ditch that is shown by the picture on page 11.
