Certificate of Substantial Completion

PROJECT: <i>(Name and address)</i> 10020-Valley View Fire Station No. 1 1273 Stump Bridge Road Canton, MS 39046	PROJECT NUMBER: 10020/ CONTRACT FOR: General Construction CONTRACT DATE: September 20, 2012	OWNER: <input type="checkbox"/> ARCHITECT: <input type="checkbox"/> CONTRACTOR: <input type="checkbox"/> FIELD: <input type="checkbox"/> OTHER: <input type="checkbox"/>
TO OWNER: <i>(Name and address)</i> Madison County Board of Supervisors PO Box 404 Canton, Mississippi	TO CONTRACTOR: <i>(Name and address)</i> Richard Womack Construction, LLC 141 Blackwell Road Mendenhall, MS 39117

FIELD OBSERVATION REPORT

PROJECT: Valley View Fire Station 1
Canton, Mississippi
JO# 10002.04

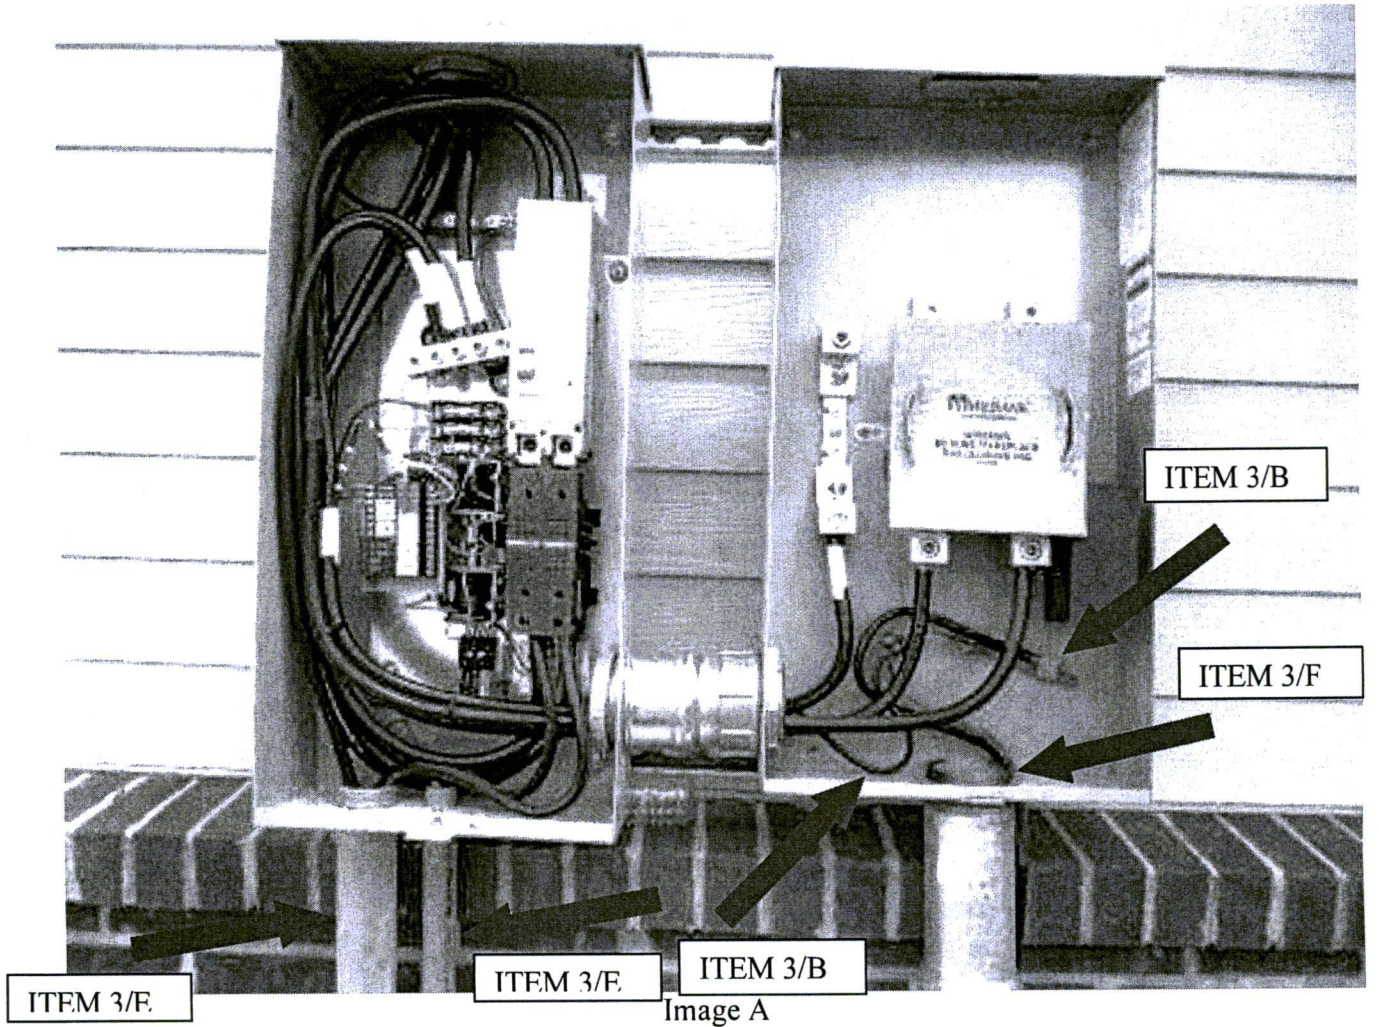
2. Smoke Detectors: The detectors were installed but could not be properly checked without utility power.
3. Power Distribution System: The panels are completed. Utility power has not been connected. The following was noted as incomplete or requiring correction; See image A.

- A. Complete grounding to water, gas and building steel per detail 2/E0.1.
 - B. Use split bolt (or other conductor termination unit) connection for grounds in meter base. Pig tail from this connection to housing bond. Replace # 4 ground conductor with # 2 conductor to the service entrance ground bar in the transfer switch.

- F. Install grounding bushing on service feeder conduit. Coat GRS conduit treads with cold Zinc galvanizing.
 - G. Detail 2/E0.1 requires three ground rods be installed in a triangle form. The Contractor has installed two ground rods in a straight line. The Contractor shall test the grounding per specification 16010 3.11 B.
