MEMO

Madison County Courthouse

Existing Facilities Analysis & Report Moisture Infiltration Investigation December 17, 2012

BELINDA STEWART ARCHITECTS, P.A. 61 North Dunn Street, P.O. Box 867
Eupora, Mississippi 39744
662.258.6405 & 662.258.6452 fax
bsa@belindastewartarchitects.com
www.belindastewartarchitects.com

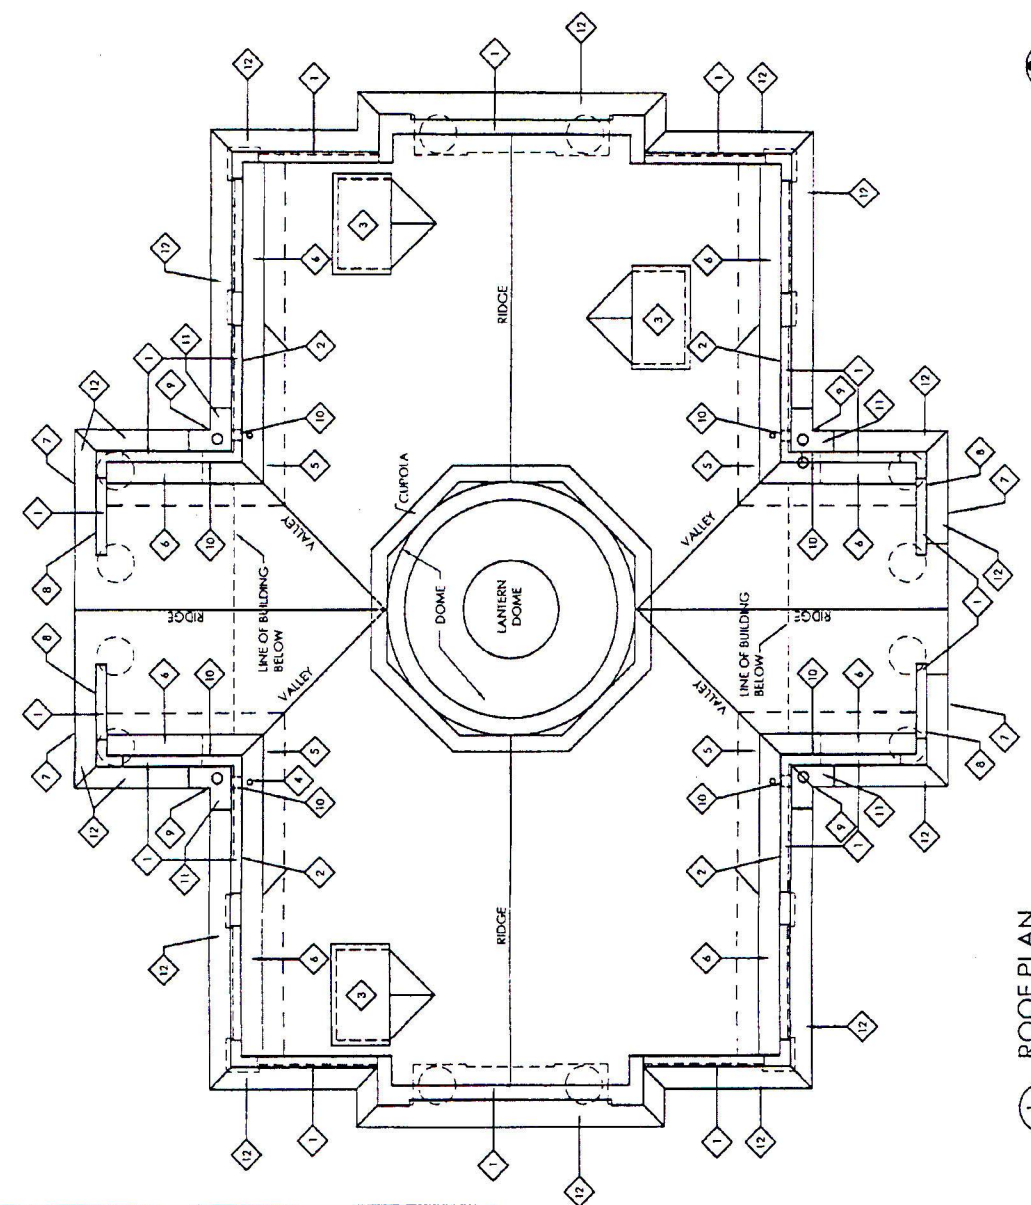
ROOF PLAN
 SCALE: 3/32" = 1'-0"

The asphalt shingled roof is in generally good condition, however, there are several problem areas related to flashings and drainage noted as likely points of water infiltration resulting in interior plaster damage. A camera scope investigation of the Roof Drains and Associated Drain Piping exhibited blockage to various degrees at 4 of the 5 drain locations. Based on findings related to roof drainage, we recommend abandoning the existing internal roof drains and installing exterior downspouts, strategically located, to minimize the visual impact on the building. Downspouts would then connect to new underground drain lines running to the east and to the west to daylight at street curbs with catch basins and cleanouts.

- ROOF PLAN NOTES:**
1. REMOVE ALL EXISTING METAL CAP FLASHING, WOOD NAILERS, SEALANTS, & RESTORE CAST STONE PARAPET CAP.
 2. REMOVE ALL MINERAL CAP ROOFING MATERIAL FROM DRAIN GUTTER AND BACK OF PARAPET WALL.
 3. EXISTING SKYLITE/DORMER, REMOVE EXISTING "ROOF" AND CONSTRUCT NEW FRAMED COVER WITH FLEXIBLE ROLLED WEATHER BARRIER AND PREFINISHED STANDING SEAM METAL ROOF.
 4. EXISTING ROOF DRAIN & BASKET, REMOVE AND ABANDON.
 5. REMOVE (5) ROWS ASPHALT SHINGLES TO ALLOW FOR INSTALLATION OF NEW MEMBRANE GUTTER LINER.
 6. NEW MEMBRANE GUTTER LINER.
 7. INSTALL NEW METAL GABLE EDGE FLASHING.
 8. INSTALL NEW REGLET FLASHING INTO BRICK MORTAR JOINT.
 9. NEW 8" DIAMETER DOWNSPOUT WITH STIFFI ROOT.
 10. NEW THRU-WALL METAL SCUPPER.
 11. NEW DRAIN "THROUGH" BUILT INTO CORNICE.
 12. NEW SLOPED CORNICE COVER FLASHING WITH HEMMED KICK DRIP AT FRONT EDGE.
