**Re:** Asbestos Bulk Sampling Report  
Madison County Emergency Management Services Complex  
1633 West Pence Street  
Canton, Mississippi  
EarthCon Project No. 02.20170326.55

On October 20, 2017, EarthCon Consultants, Inc. (EarthCon) conducted an asbestos bulk sampling of the metal roof material at the Madison County Emergency Management Services Complex located at 1633 West Pence Street in Canton, Mississippi. The sampling was conducted by Mr. W. Hal Moore, Mississippi Certification No. ABI-00002284, expiration date January 25, 2018, and Mr. Reginald Sampson, Mississippi Certification No. ABI-00001921, expiration date September 28, 2018, to evaluate the roof for the presence of asbestos-containing materials (ACMs) prior to replacement. This report describes the inspection tasks and presents our findings and recommendations.

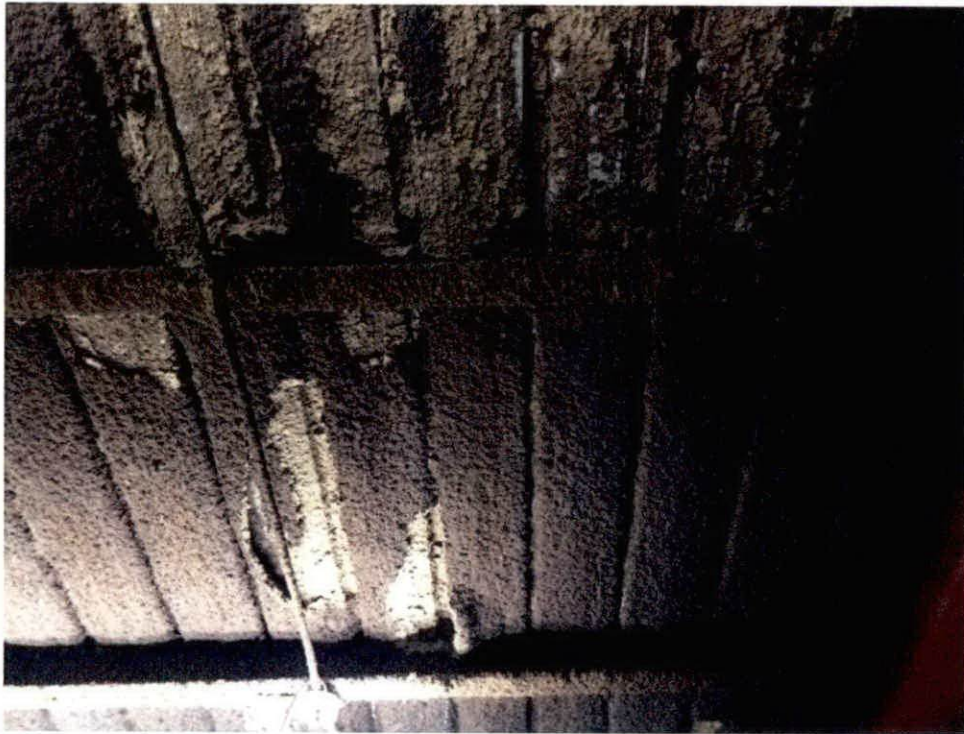
**Photo 2:** Spray Applied Ceiling Insulation
