PROJECT: <i>(name and address)</i> 1208.3 Madison County Courthouse Cupola Repairs & Restoration Canton Mississippi	CONTRACT INFORMATION: Contract For: Construction Date: May 15, 2017	CERTIFICATE INFORMATION: Certificate Number: 001 Date: January 5, 2018
OWNER: <i>(name and address)</i> Madison County Board of Supervisors PO Box 608 Canton Mississippi 39046	ARCHITECT: <i>(name and address)</i> Belinda Stewart Architects, PA PO Box 867 Eupora MS 39744	CONTRACTOR: <i>(name and address)</i> Paramount Construction Group, LLC 334 West School Street, Ste B Ridgeland MS 39157

Field Report No. 9

Date: December 20, 2017
Project: Madison County Courthouse
Cupola Repairs & Restoration
Canton, Mississippi
BSA No. 1208.3
Contractor: Paramount Construction Group, LLC
Weather: ~ 67° F – Cloudy & Windy
Present: Craig Bjorgum – Belinda Stewart Architects, P.A. – BSA
Danny Lee and Shelton Vance – Madison County
Clint Bledsoe – Paramount Construction Group, LLC (PCG)
Matt Moore – Historic Renovations of Yazoo

Field Report No. 10

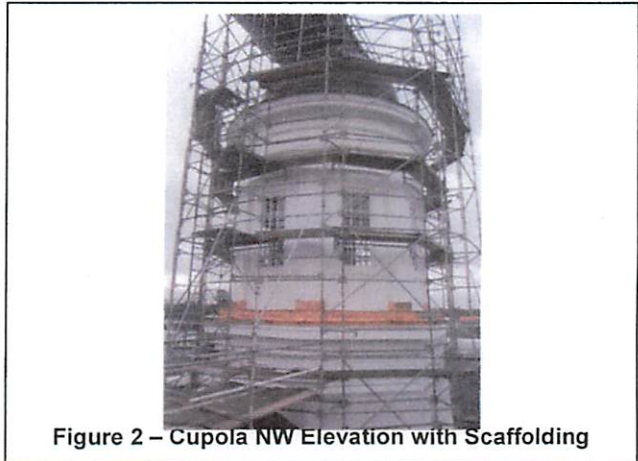
Figure 2 – Cupola NW Elevation with Scaffolding

- 1 - All scaffolding to be removed upon completion of work and final review. **Figure 2**
- 2 - All roofing surfaces (Membrane and Asphalt Shingles) and components will be reviewed for damages upon final completion and removal of scaffolding. Any noted damage/conditions will be assessed and corrective action determined at that time.

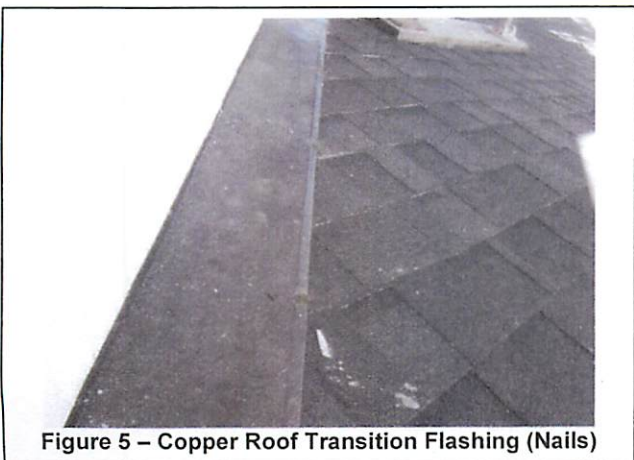
Figure 5 – Copper Roof Transition Flashing (Nails)

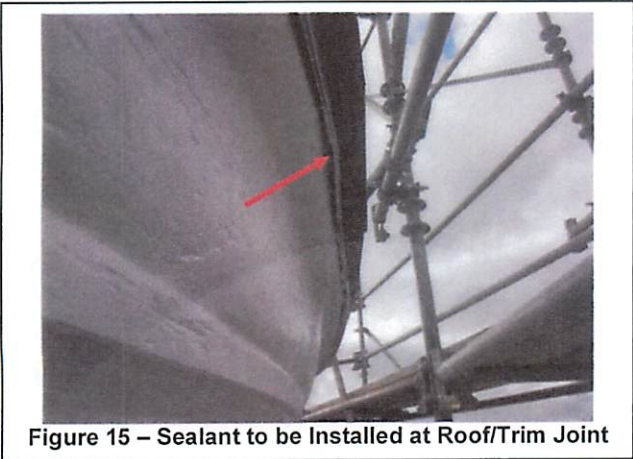
Figure 15 – Sealant to be Installed at Roof/Trim Joint

- 21 - Perimeter Joint at Underside of Main Copper Cupola Tile Roof – Remove/ Trim out roofing felt and install continuous bead of sealant. **Figure 15**

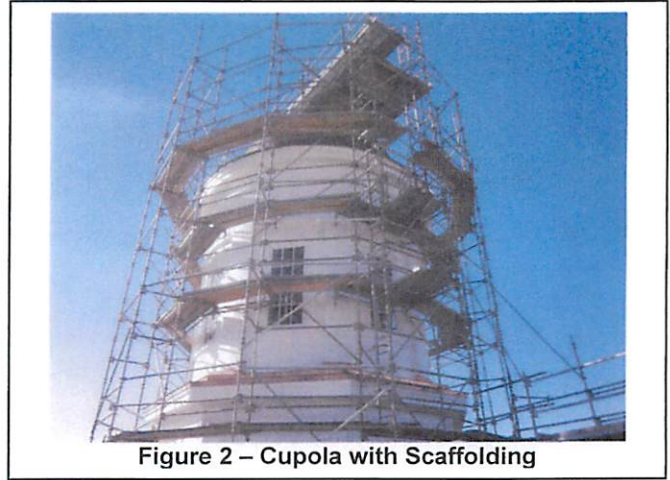
Figure 2 – Cupola with Scaffolding

- 1 - All scaffolding to be removed upon completion of work and final review. **Figure 2**
- 2 - All roofing surfaces (Membrane and Asphalt Shingles) and components will be reviewed for damages upon final completion and removal of scaffolding. Any noted damage/conditions will be assessed and corrective action determined at that time.
